## PUBLIC LAND SURVEY MONUMENT RECORD

# Government Land Corner Certificate

CORNER NO. 59  
 SECTION 14  
 TOWN 16  
 RANGE 7

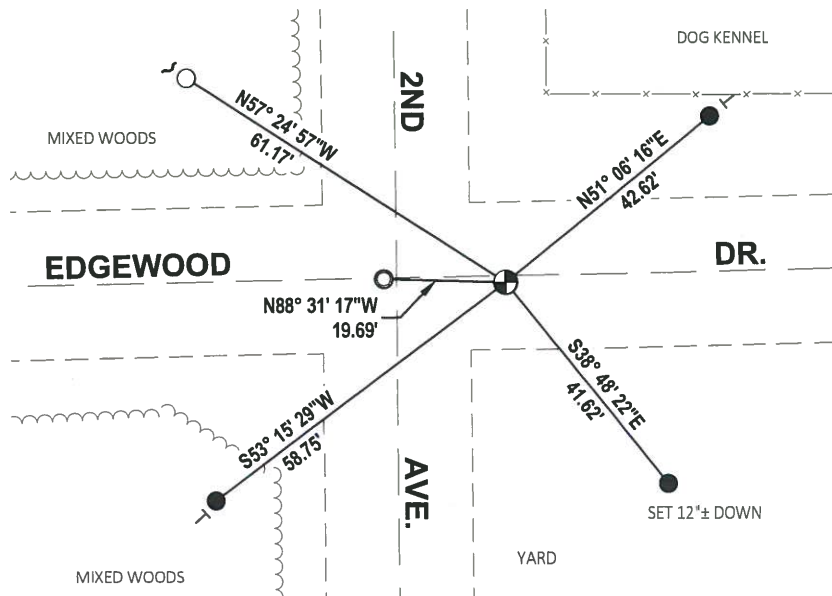
### - TIE SKETCH

2020 - PLS 2675 FOUND HARRISON 8"± BELOW THE ROAD SURFACE AND 1 TIE. THE MONUMENT AGREES WITH THE EXISTING TIE AND IS ON A NEAR STRAIGHT LINE AND EQUIDISTANT SPLIT FROM THE SE AND NE CORNERS OF SECTION 14. ACCEPTED THE HARRISON AS THE CORNER LOCATION. SET 3 NEW TIES AND MEASURED TO THE EXISTING TIE AND FOUND PROPERTY IRON.

NOTE: THE CORNER LANDS 17.1'± EAST OF 2ND AVE. CENTERLINE AND 1.2'± SOUTH OF EDGEWOOD DR. CENTERLINE.

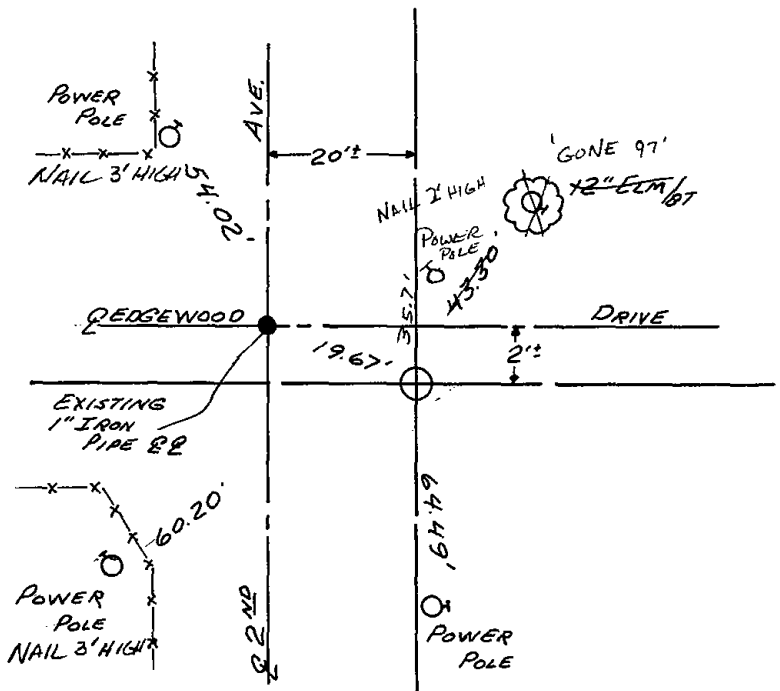
## TIE SKETCH

No resurveys of record. Excavated with backhoe 10 to 25 feet east of existing iron pipe. Found nothing. According to adjacent landowner, road was shifted to the west to bypass farm buildings. There is a noticeable bend in the road north of here. Corner was set on line equidistant between section corners.

Ties are to nail nad disc.
