PUBLIC LAND SURVEY MONUMENT RECORD

TYPE OF MONUMENT: HARRISON (BROKEN-TOP)

FIELD WORK DATE: 08/07/2018

CORNER NO. 495

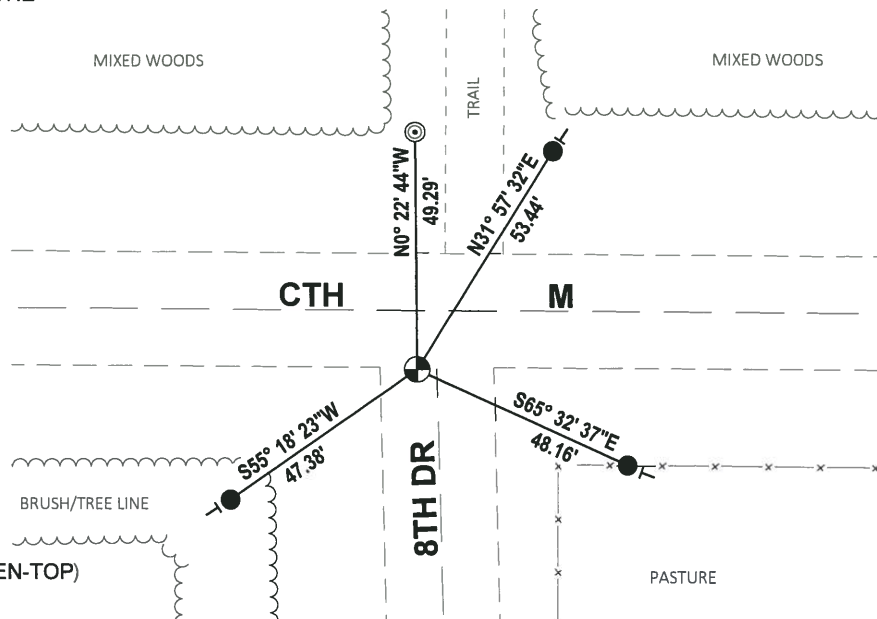
- TIE SKETCH

2018 - PLS 2994 FOUND A HARRISON MONUMENT WITH A BROKEN-TOP 4" BELOW THE ROAD SURFACE AND 1 TIE. THE MONUMENT AGREES WITH THE EXISTING TIE. ACCEPTED THE HARRISON MONUMENT WITH A BROKEN-TOP AS THE CORNER LOCATION. SET 3 NEW TIES AND MEASURED TO THE TIES.

NOTE: THE CORNER FALLS 12± SOUTH OF THE CENTERLINE OF CTH M AND 4± WEST OF THE CENTERLINE OF 8TH DR.

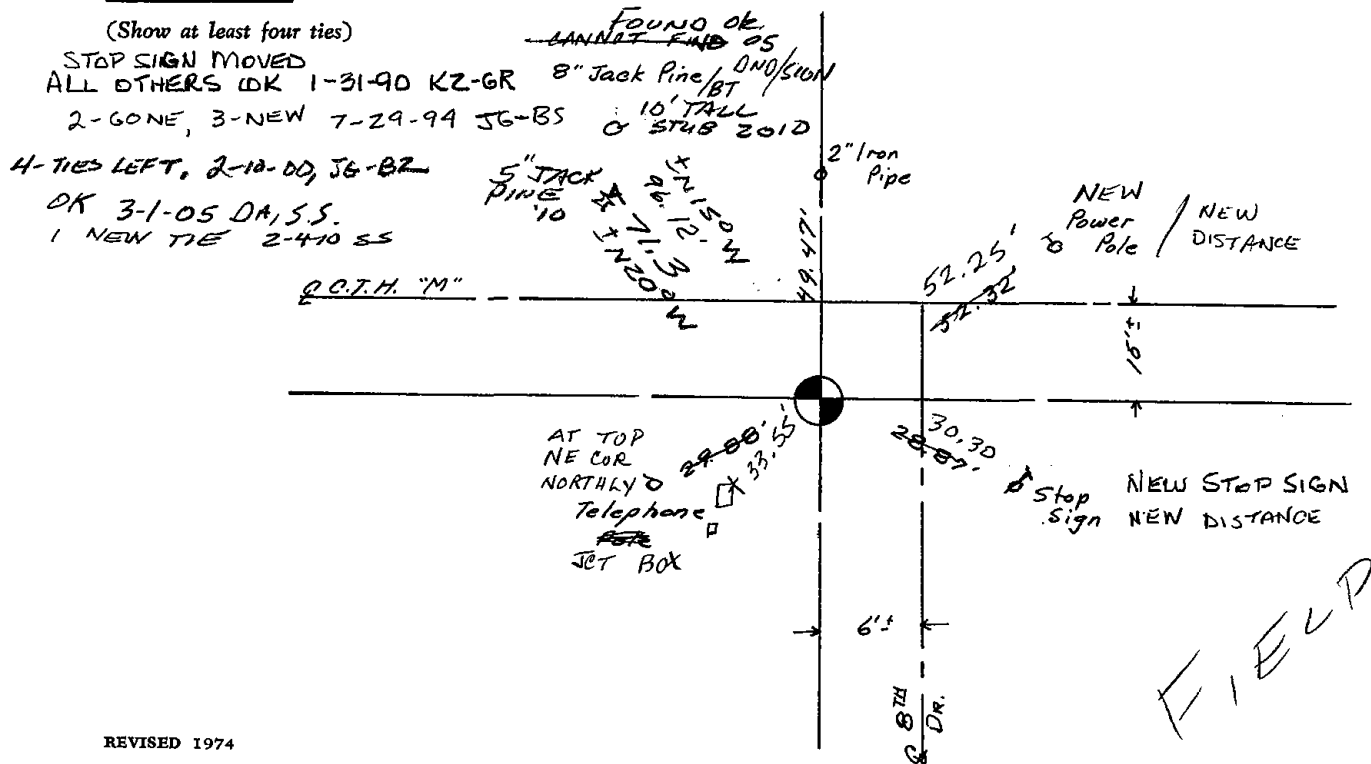
TIE SKETCH

Ran EMD/transit traverse between Northeast and Northwest corners of Section 14.

No evidence as to the location of the Quarter corner was found, though there exists a pipe at a fence corner toward the North. There is no evidence in the County Surveyor's office as to the origin of this pipe.

According to Section 59.62 of the Wisconsin Statutes, the Quarter corner was set equidistant and on line between the Northeast and Northwest Section corners.
