31 SECTION 17 TOWN 06 RANGE

# ADAMS COUNTY

COUNTY CORNER NO: 115  
ROMPORTOL ID: 41706312000

## PUBLIC LAND SURVEY MONUMENT RECORD

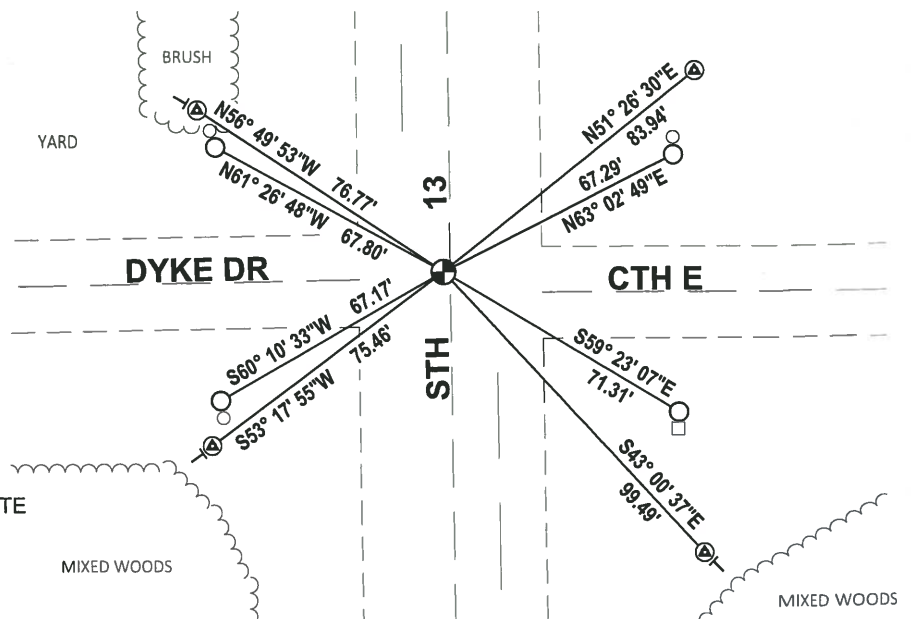
### TIE SKETCH

2018 - PLS 2675 FOUND A 3/4" IRON ROD 6" BELOW THE ROAD SURFACE, 4 TIES AND 4 R/W IRONS. THE MONUMENT AGREES WITH THE EXISTING TIES. ACCEPTED THE 3/4" IRON ROD AS THE CORNER LOCATION. RE-MEASURED TO THE EXISTING TIES AND R/W IRONS.

NOTE: THE CORNER FALLS 2'± WEST OF THE CENTERLINE OF STH 13 AND 2' NORTH OF THE CENTERLINE OF DYKE DR.

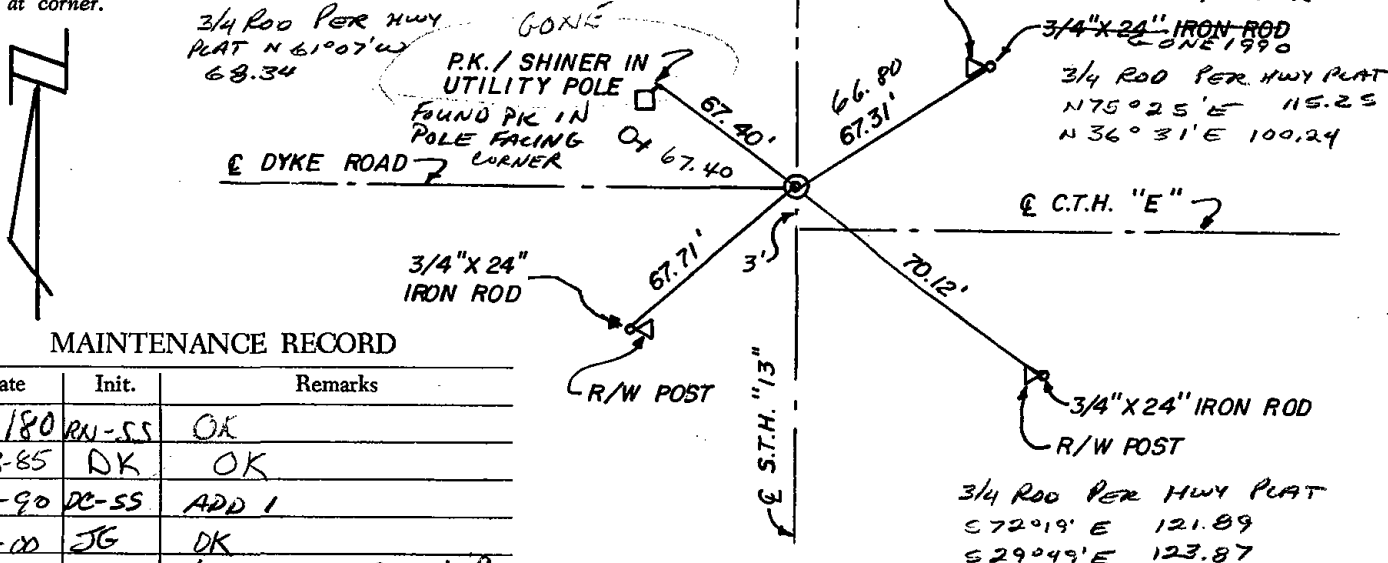
## TIE SKETCH

Found R.R. spike set by persons unknown. Ran EDM traverse of Sections 31 & 32. Fit occupation of properties within a quarter mile within reason. If this corner were to be reset by single proportion it would result in a serious encroachment upon an old cemetery which is 32 rods to the east. It would appear to me as if the northeast corner of Section 31 were moved to the west the section would look better.

Date	Init.	Remarks
4/29/80	RW-SS	OK
7-18-85	DK	OK
5-23-90	DC-SS	ADD 1
2-14-00	JG	DK
1-28-05	JG	OK, CHECK R.O.W. PLAT
