## PUBLIC LAND SURVEY MONUMENT RECORD

TYPE OF MONUMENT: HARRISON (BROKEN-TOP)  
 ADAMS COUNTY COORDINATES, NAD 83 (2007)

**ADAMS COUNTY**

CORNER NO. 54  
 SECTION 18  
 TOWN 16  
 RANGE 6E

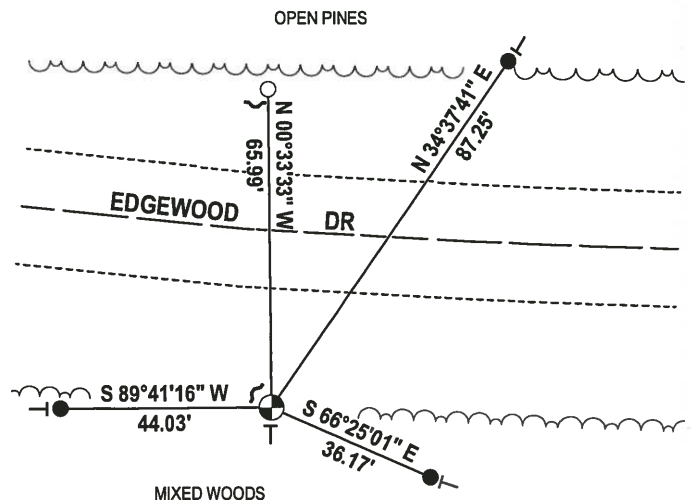
### - TIE SKETCH

2017 - PLS 2994 FOUND A HARRISON MONUMENT WITH A BROKEN-TOP 6" BELOW THE GROUND SURFACE AND 1 TIE. THE MONUMENT AGREES WITH THE EXISTING TIE. ACCEPTED THE HARRISON MONUMENT AS THE CORNER LOCATION. SET 3 NEW TIES AND MEASURED TO THE TIES.

NOTE: THE CORNER FALLS 37'± SOUTH OF THE CENTERLINE OF EDGEWOOD DR.

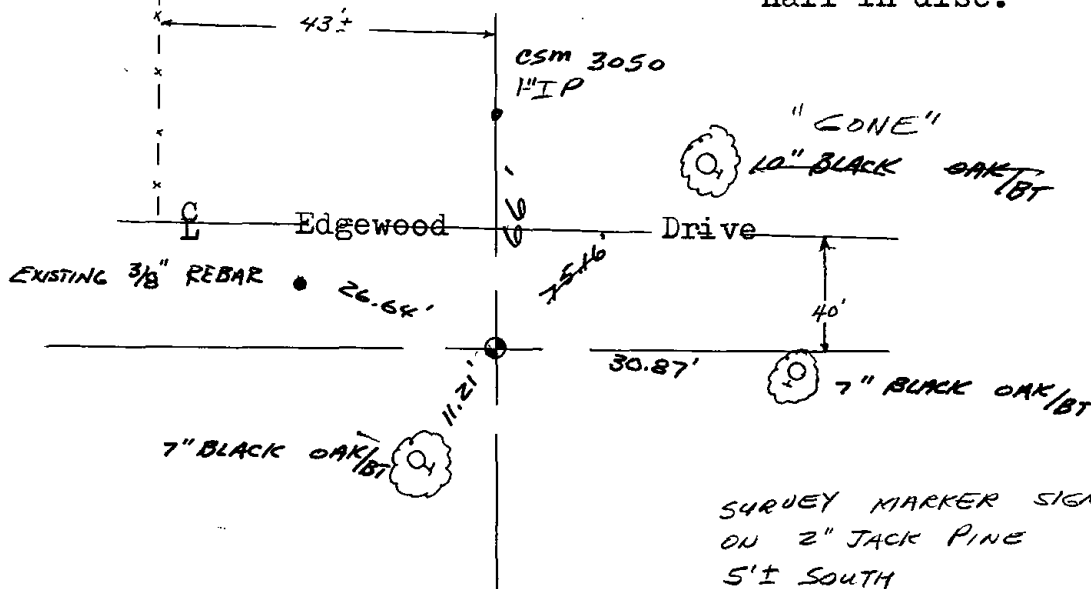
**TIE SKETCH** ALL OK 5-17-00 - JG  
 1-GONE, 2-28-05 - JG  
 1-15-10, SS  
 (Show at least four ties)

COR OK 10/20/80 KU SK  
 TOP BROKEN - BOTTOM IN PLACE 10-31-85 MB-SS  
 OK 1-9-90 GR-KZ  
 " 2-6-95 JG-GR

**NOTE:**  
 Ties in trees to nail in disc.
