PUBLIC LAND SURVEY MONUMENT RECORD

U.S. PUBLIC LAND SURVEY MONUMENT RECORD

ADAMS COUNTY

CORNER NO. 95

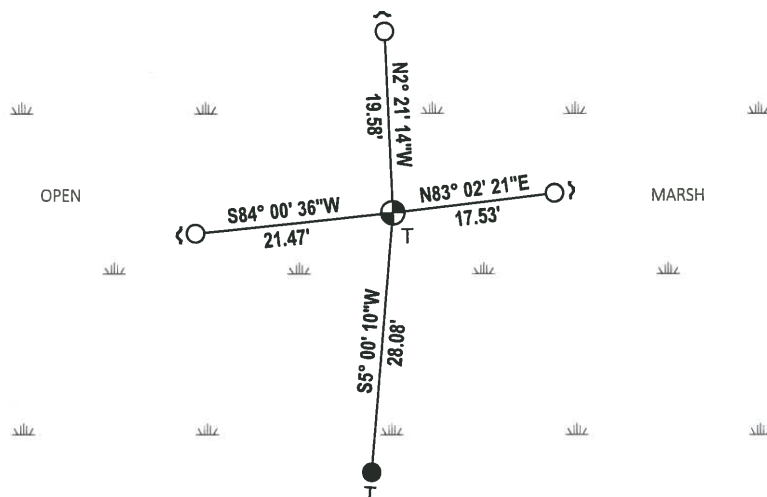
TIE SKETCH

2020 - PLS 2675 FOUND 2-3/8" O.D. IRON PIPE 18"± ABOVE THE MARSH SURFACE AND 3 TIES. THE MONUMENT AGREES WITH ALL 3 TIES. ACCEPTED THE 2-3/8" O.D. IRON PIPE AS THE CORNER LOCATION. SET 1 NEW TIE AND MEASURED TO THE EXISTING TIES.

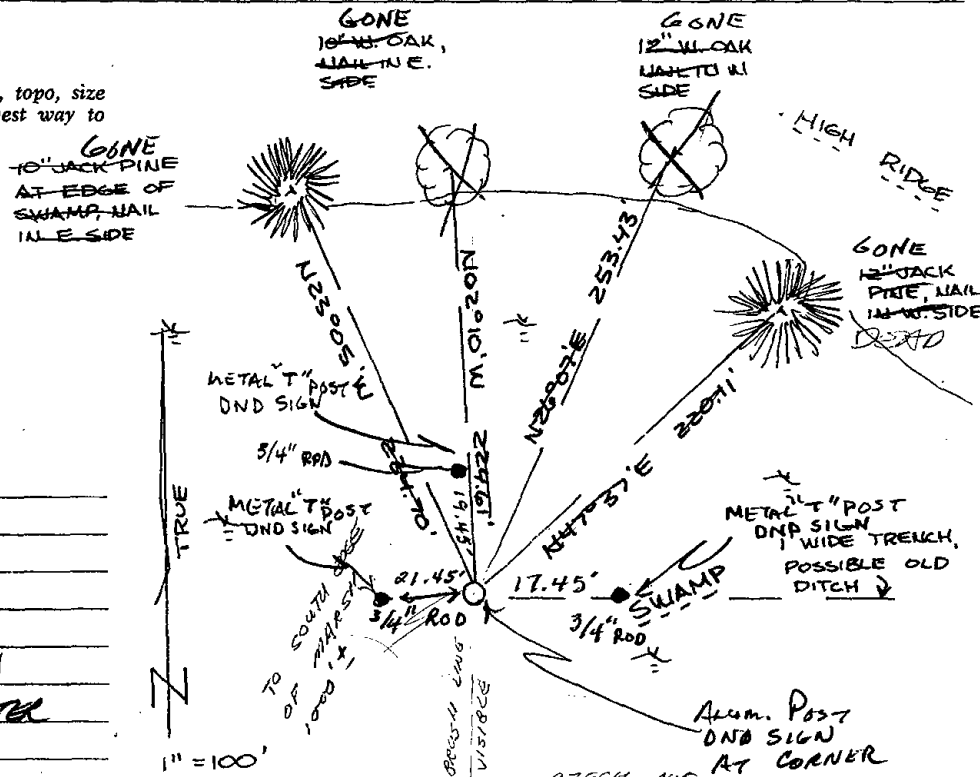
TIE SKETCH

STEEL POST/NO TRESPASS SIGN @ COR.

Date	Init.	Remarks
2-10-87	SS	OK
12-4-91	KZ-JG	OK
4-21-97	JG-SS	OK
1-08-02	JG	4-GONE, 3-NEW
4-3-07	JG	OK, HIGH WATER
