29
SECTION

COUNTY CORNER NO: 96

PUBLIC LAND SURVEY MONUMENT RECORD

U.S. PUBLIC LAND SURVEY MONUMENT RECORD

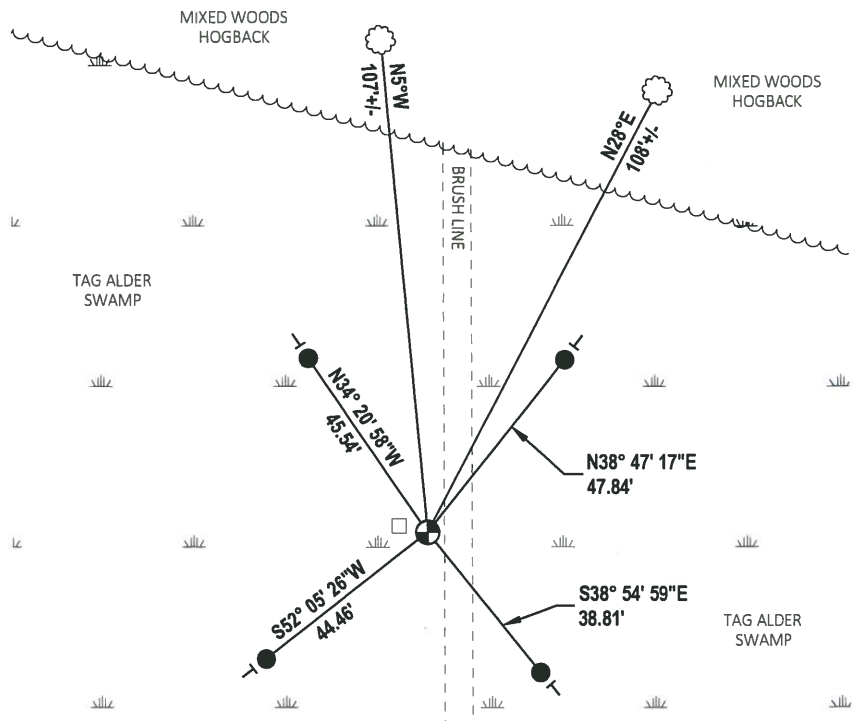
- TIE SKETCH

2020 - PLS 2675 FOUND 2-3/8" IRON PIPE 12"± ABOVE THE MARSH SURFACE AND 2 WITNESS TREES. THE IRON PIPE AGREES WITH BOTH WITNESS TREES. ACCEPTED THE 2-3/8" O.D. IRON PIPE AS THE CORNER LOCATION. SET 4 NEW TIES AND MEASURED TO THE EXISTING WITNESS TREES.

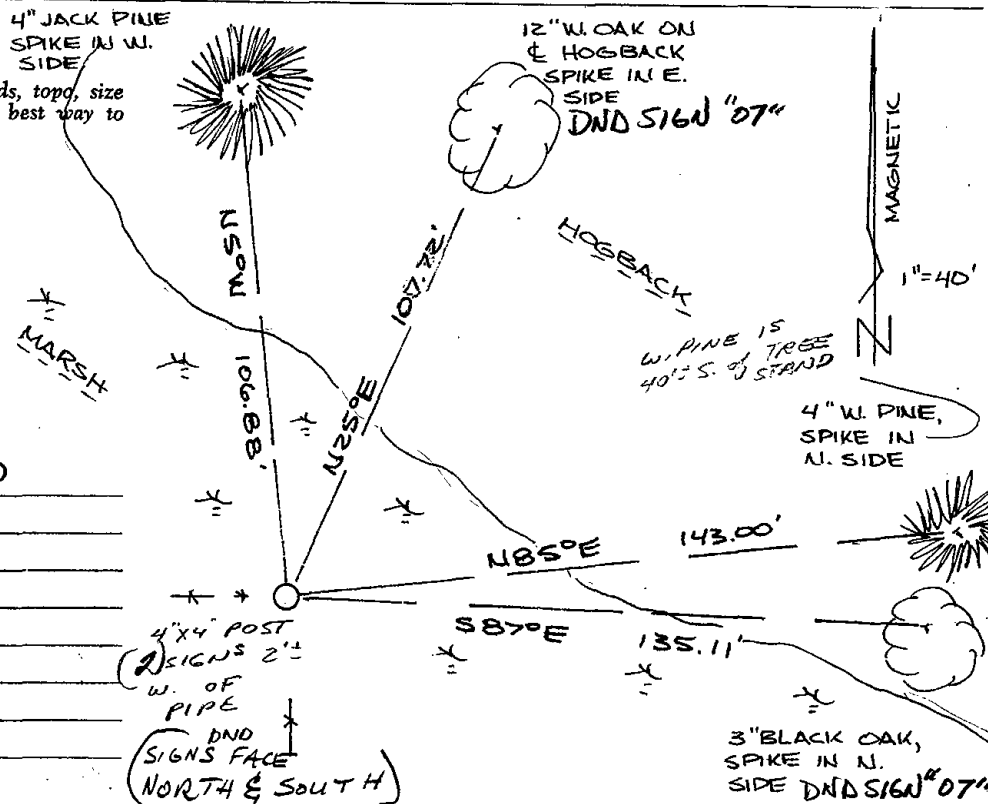
TIE SKETCH

No evidence of bearing trees remain.
Search of corner area yielded the base of an old corner post rotted off. Remains of barb wire were also found extending to the West, and an old fence post was found to the South.

2" pipe was driven at the base of corner post and accepted as correct.

This location lines in on a very old fence line along the East line of the SE 1/4, and is within 0.6' of the original distance from the South.

4" x 4" POST
(2) SIGNS 2"
W. OF
PIPE
DND
SIGNS FACE
(NORTH & SOUTH)
