ADAMS COUNTY

COUNTY CORNER NO: 30

PUBLIC LAND SURVEY MONUMENT RECORD

Government Land Corner Certificate

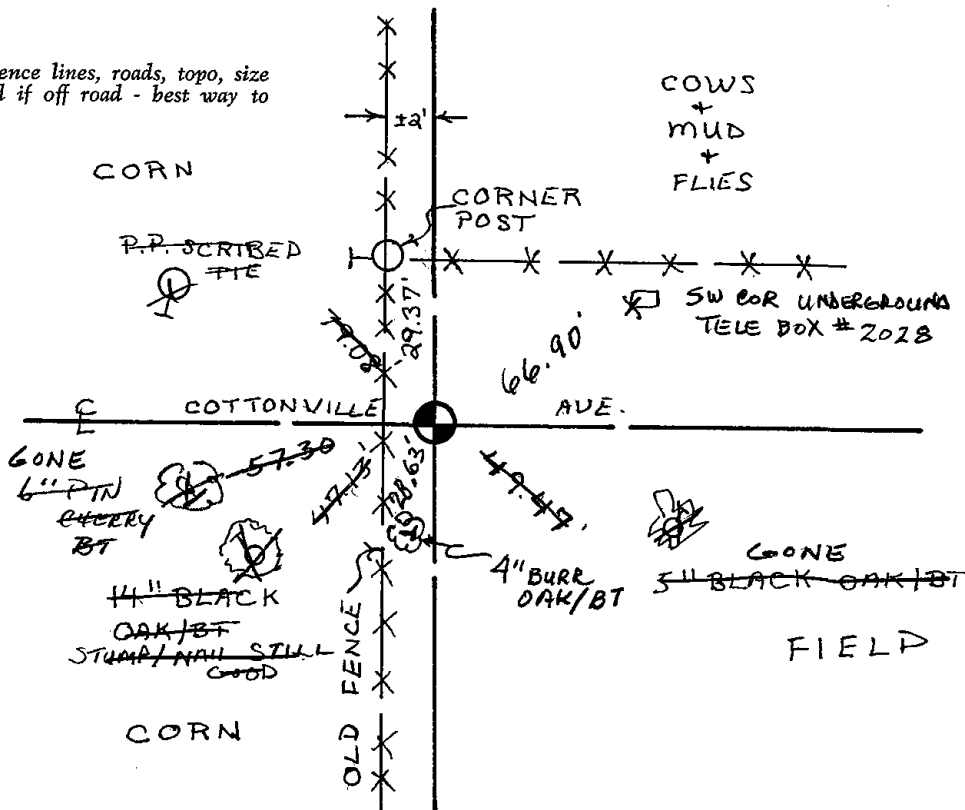
TIE SKETCH

No record of any resurveys. Excavated area with backhoe, found nothing. This point set half way between section corners, and on centerline of road. There appears to be a band in the road at this point, and could not justify a straight line between section corners.
