ADAMS COUNTY

COUNTY CORNER NO: 100
ROMPORTOL ID: 42006252000

PUBLIC LAND SURVEY MONUMENT RECORD

Government Land Corner Certificate

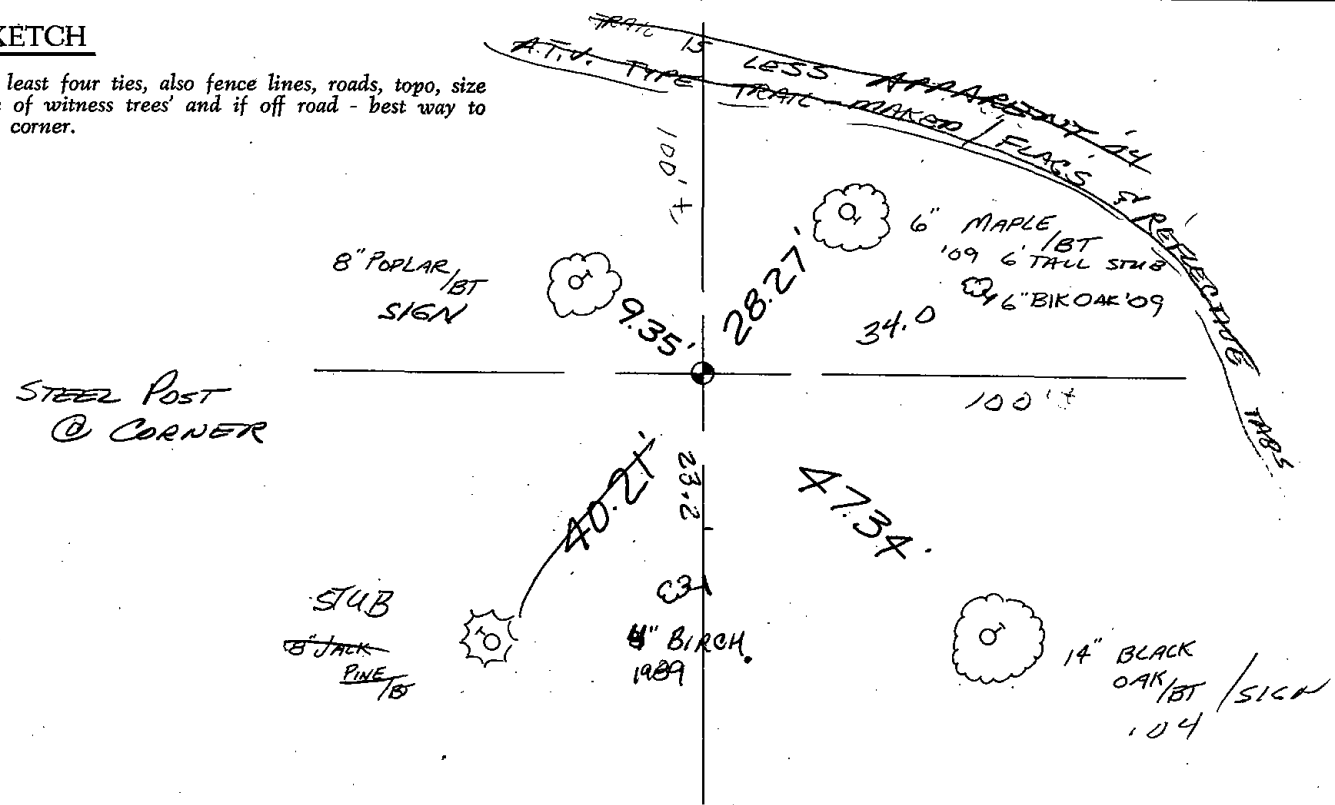
TIE SKETCH

Set single proportionate and on line between the NE corner of section 13-20-6 and the SE corner of section 25-20-6, after an extensive EDM/transit traverse of sections 13, 24, 25, 36, T20N, R6E and sections 18, 19, 30, 31, T20N, R7E, and careful search revealed no evidence of previous monumentation at this corner.
