PUBLIC LAND SURVEY MONUMENT RECORD

TYPE OF MONUMENT: HARRISON
ADAMS COUNTY COORDINATES, NAD 83 (2007)

Survey Monument Record

CORNER NO. 72
 1092
 SECTION 24
 TOWN 14 N
 RANGE 7 E

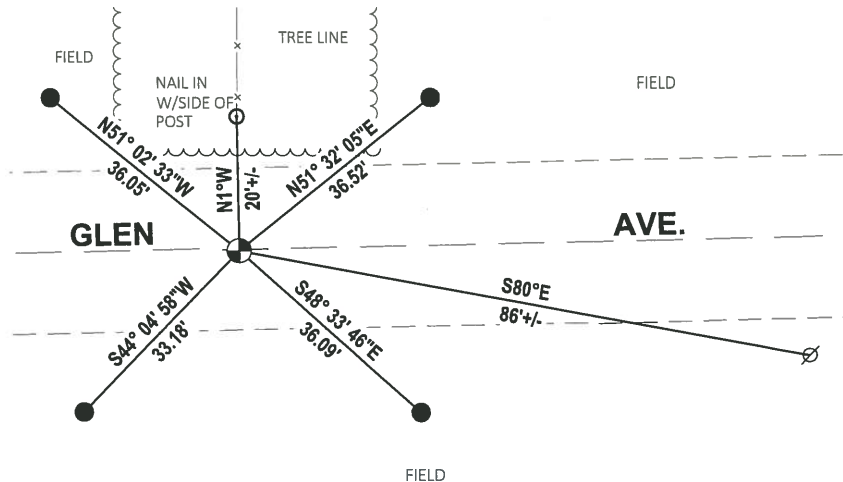
- TIE SKETCH

2020 - PLS 2675 FOUND HARRISON FLUSH WITH THE ROAD SURFACE AND 2 WITNESSES. THE MONUMENT AGREES WITH BOTH WITNESSES. ACCEPTED THE HARRISON AS THE CORNER LOCATION. SET 4 NEW TIES AND MEASURED TO THE EXISTING WITNESSES.

NOTE: THE CORNER LANDS ON THE CENTERLINE OF GLEN AVE.

NOTE: ALL TIES ARE SET 24"± DOWN

- SET 3/4" x 18" IRON REBAR, 1.50#/FT
- ⊕ FOUND HARRISON MONUMENT
- ∅ WITNESS POWER POLE

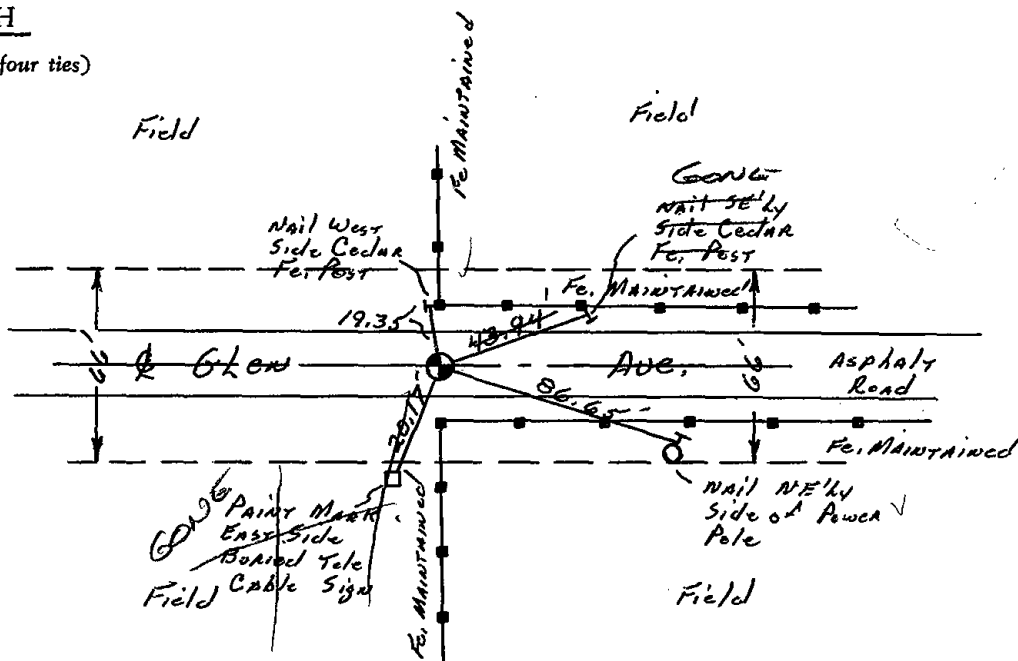
TIE SKETCH

Research Adams county survey notes found nothing on Record as being set at this corner. Original notes for two bearing trees which have both been destroyed logged off in the years since the original govt performed. Sounded for iron in Road could find Dug hole in center of Road and found remnant vertically in ground at approximately 2' below Road. This wood being very decomposed and in line line used it for being corner post and set HARRISON at this point
 Edm Traverse

Date	Init.	Remarks
12-8-81	SK-DW	Ties o.k
3-5-86	GR-SS	OK
8-27-91	SS-JG	OK
3-29-02	JG-SS	1-GONE
1-27-06	JG	OK
Nov 11	SS	OK
