03 SECTION 19 TOWN 06 RANGE

ADAMS COUNTY

COUNTY CORNER NO: 18
 ROMPORTOL ID: 41906032000

PUBLIC LAND SURVEY MONUMENT RECORD

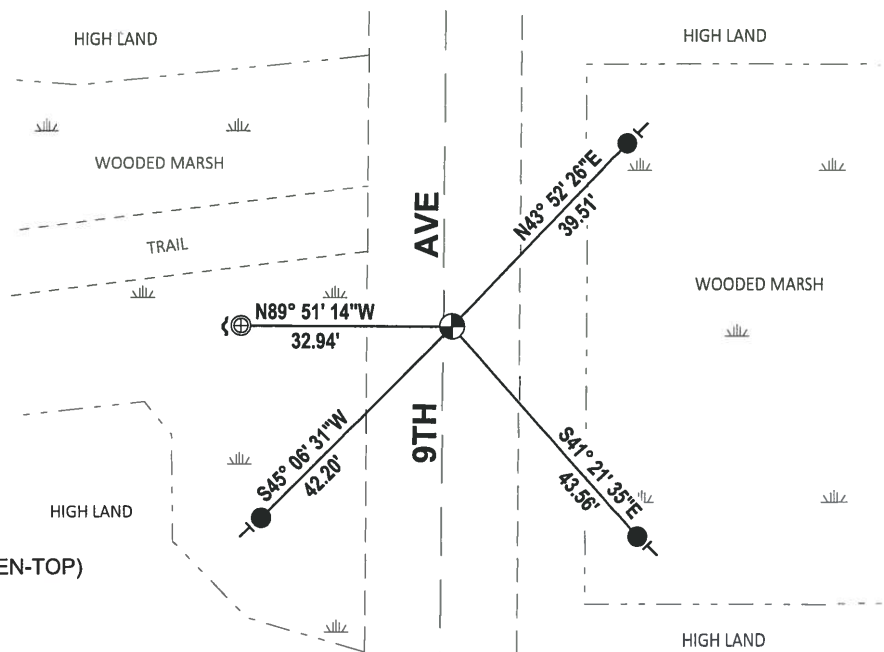
- TIE SKETCH

2018 - PLS 2675 FOUND A HARRISON MONUMENT WITH A BROKEN-TOP 8" BELOW THE ROAD SURFACE AND 1 PROPERTY IRON. FOUND NO EVIDENCE OF ANY OF THE EXISTING TIES OR WITNESSES. ACCEPTED THE HARRISON MONUMENT WITH A BROKEN-TOP AS THE BEST EVIDENCE OF THE CORNER LOCATION. SET 3 NEW TIES AND MEASURED TO THE TIES AND PROPERTY IRON.

NOTE: THE CORNER FALLS 1 1/2 EAST OF THE CENTERLINE OF 9TH AVE.

- SET 3/4" x 18" IRON REBAR, 1.50#/FT
- ⊕ FOUND 1" O.D. IRON PIPE
- ⊙ FOUND HARRISON MONUMENT (BROKEN-TOP)
- ~ STEEL FENCE POST
- VINYL "T" POST

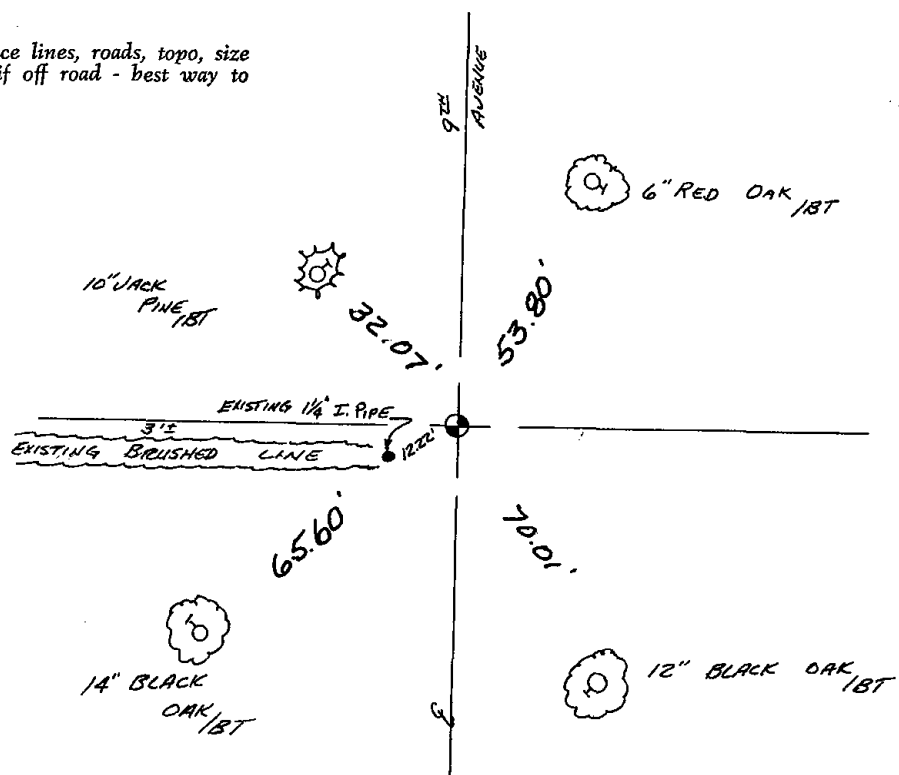
TIE SKETCH

Set at a location single proportionate ^{distance} between adjacent section corners and on the centerline of town road.
 Excavation with backhoe yielded no evidence of any previous monumentation.
