17 SECTION 19 TOWN 07 RANGE

ADAMS COUNTY

COUNTY CORNER NO: 65
ROMPORTOL ID: 41907170000

PUBLIC LAND SURVEY MONUMENT RECORD

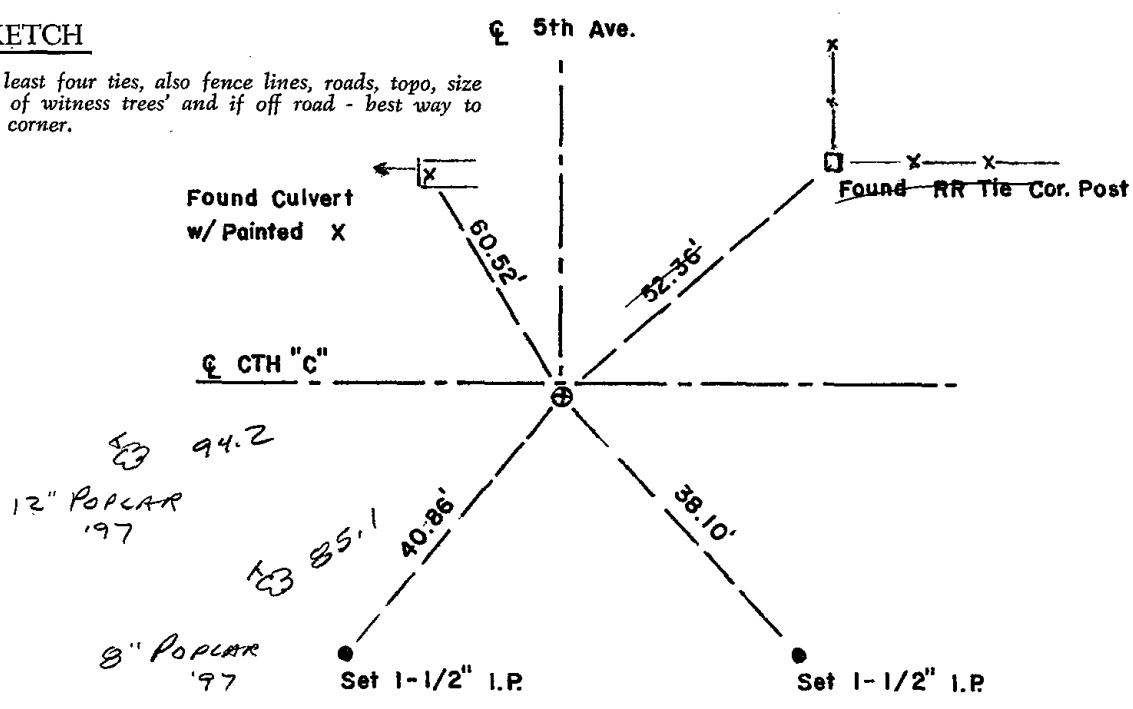
TIE SKETCH

I accepted the location by Kiedrowski.
 The Southwest and Southeast Aspen trees were dead.
 The Northwest and Northeast ties were found as recorded.
 I rereferenced as shown below.
