PUBLIC LAND SURVEY MONUMENT RECORD

TYPE OF MONUMENT: SURVEY NAIL
ADAMS COUNTY COORDINATES, NAD 83 (2007)

Government Land Corner Certificate

CORNER NO. 68
 SECTION 15
 TOWN 14
 RANGE 7

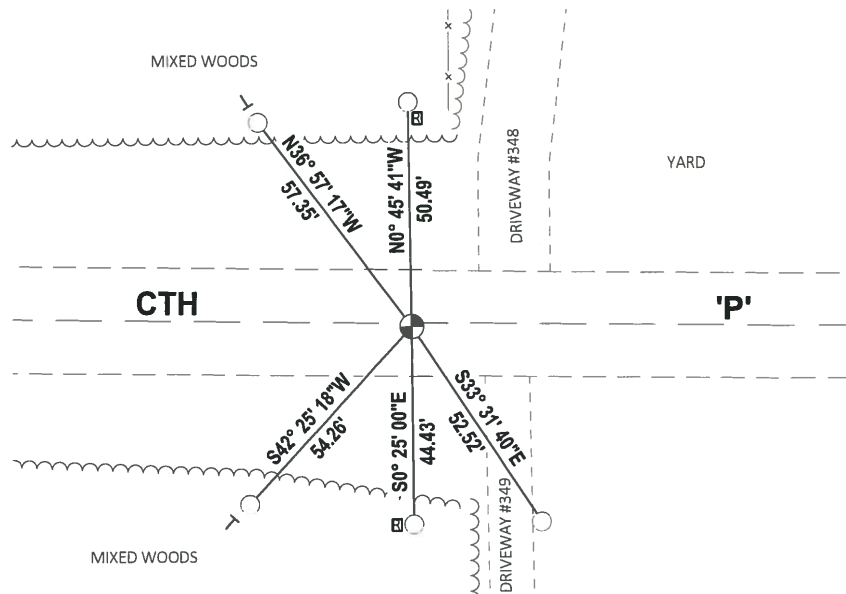
- TIE SKETCH

2020 - PLS 2675 FOUND SURVEY NAIL IN THE ROAD SURFACE, REMOVED AND FOUND NO ADDITIONAL MONUMENTS BELOW. VERIFIED CORNER BY SECTION SUMMARY DISTANCE BETWEEN THE S₁ AND SE CORNER OF SECTION 15. ACCEPTED THE SURVEY NAIL AS THE BEST EVIDENCE OF THE CORNER LOCATION AND MEASURED TO 5 FOUND PROPERTY IRONS.

NOTE: THE CORNER LANDS .8± SOUTH OF CTH 'P' CENTERLINE.

- FOUND 3/4" IRON ROD
- FOUND SURVEY NAIL MONUMENT
- ▣ RIGHT OF WAY GUARD POST
- ┊ VINYL "T" POST

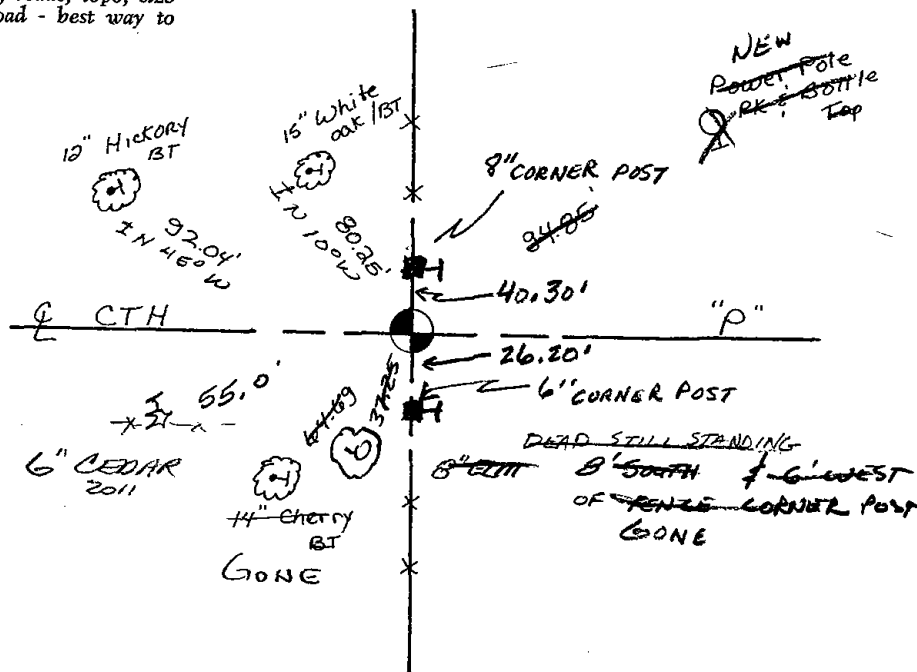
TIE SKETCH

Excavated with backhoe at this location, found no evidence of original post or any resurvey monuments. Also, no indication of any bearing trees. Roadway falls in slight cut in this area. Therefore, determined this corner to be obliterated and center-line - fence line evidence was determined to be the best evidence available in resetting this corner.
