ADAMS COUNTY

COUNTY CORNER NO: 96

PUBLIC LAND SURVEY MONUMENT RECORD

Government Land Corner Certificate

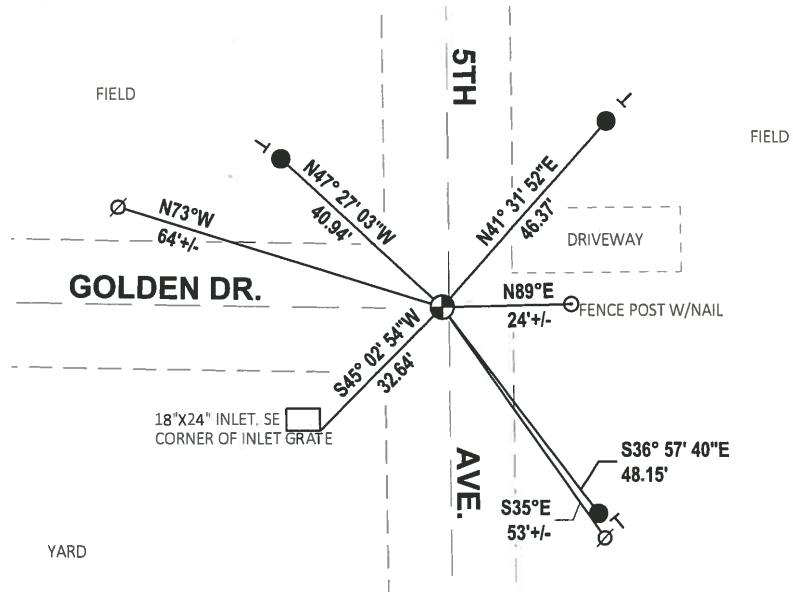
TIE SKETCH

2020 - PLS 2675 FOUND HARRISON 4"± BELOW THE ROAD SURFACE, 1 TIE AND 3 WITNESSES. THE MONUMENT AGREES WITH THE TIE AND ALL WITNESSES. ACCEPTED THE HARRISON AS THE CORNER LOCATION. SET 3 NEW TIES AND MEASURED TO THE EXISTING TIE AND WITNESSES.

NOTE: THE CORNER LANDS 1.4'± WEST OF 5TH AVE. CENTERLINE.

- SET 3/4" x 18" IRON REBAR, 1.50#/FT
- ⊕ FOUND HARRISON MONUMENT
- ⊙ WITNESS POWER POLE
- VINYL "T" POST
