PUBLIC LAND SURVEY MONUMENT RECORD

ADAMS COUNTY Survey Monument Record

CORNER NO. 531
SECTION 25
TOWN 16
RANGE 6

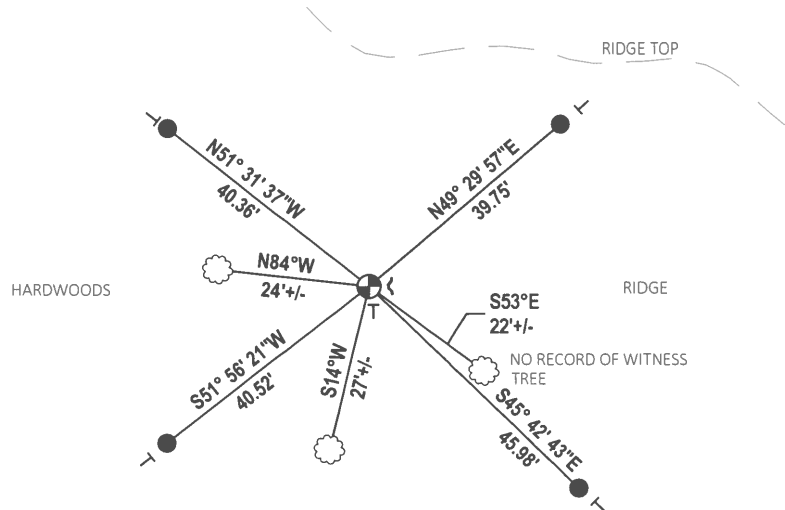
- TIE SKETCH -

2020 - PLS 2675 FOUND HARRISON 3"± ABOVE THE GROUND AND 2 WITNESS TREES. THE MONUMENT AGREES WITH BOTH WITNESS TREES. ACCEPTED THE HARRISON AS THE CORNER LOCATION. SET 4 NEW TIES AND MEASURED TO THE EXISTING WITNESS TREES.

NOTE: CORNER IS 116"± SOUTH OF NORTH EDGE OF BLUFF, 126"± TO CL OF ROAD FROM EDGE OF BLUFF.

- SET 3/4" x 18" IRON REBAR, 1.50#/FT
- ⊕ FOUND HARRISON MONUMENT
- ↘ STEEL FENCE POST
- ┌ VINYL "T" POST
- ☁ WITNESS TREE

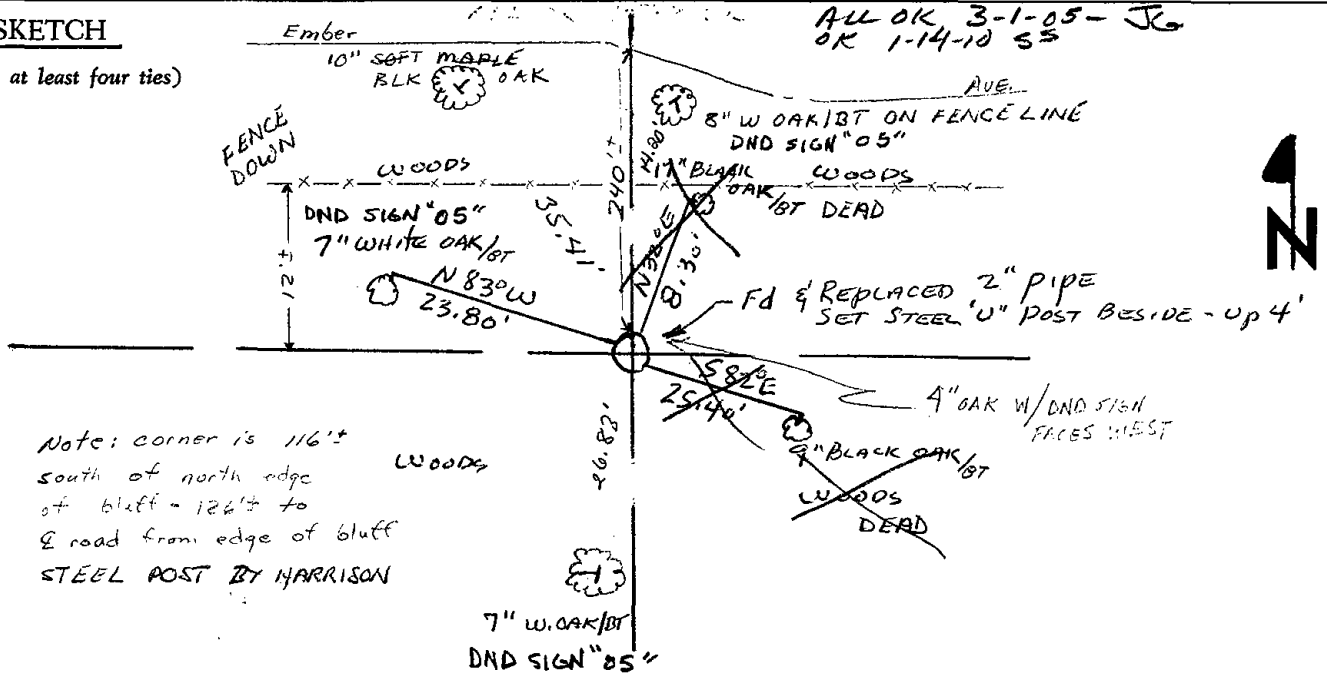
TIE SKETCH

TIES ARE TO 20th SPIKES
FOUND 2" PIPE FROM PREVIOUS RECORDED SURVEY & REPLACED - SET IRON "U" FENCE POST BESIDE MONUMENT.
AREA IS RECENTLY BURNED OUT WOODS AND UNDER BRUSH.
MEASUREMENTS ARE HORIZONTAL.

Corner checked - 11/11/75 All O.K. — DM-SS
COR OK 10/17/80 KU-SK
ALL OK 7-15-85 D.K.
OK 1-30-90 GR ALL OK 1/31/95 CR-J6

Note: corner is 116'
south of north edge
of bluff - 124' to
& road from edge of bluff
STEEL POST BY HARRISON
