PUBLIC LAND SURVEY MONUMENT RECORD

Government Land Corner Certificate

CORNER NO. 46
SECTION 9
TOWN 17
RANGE 5

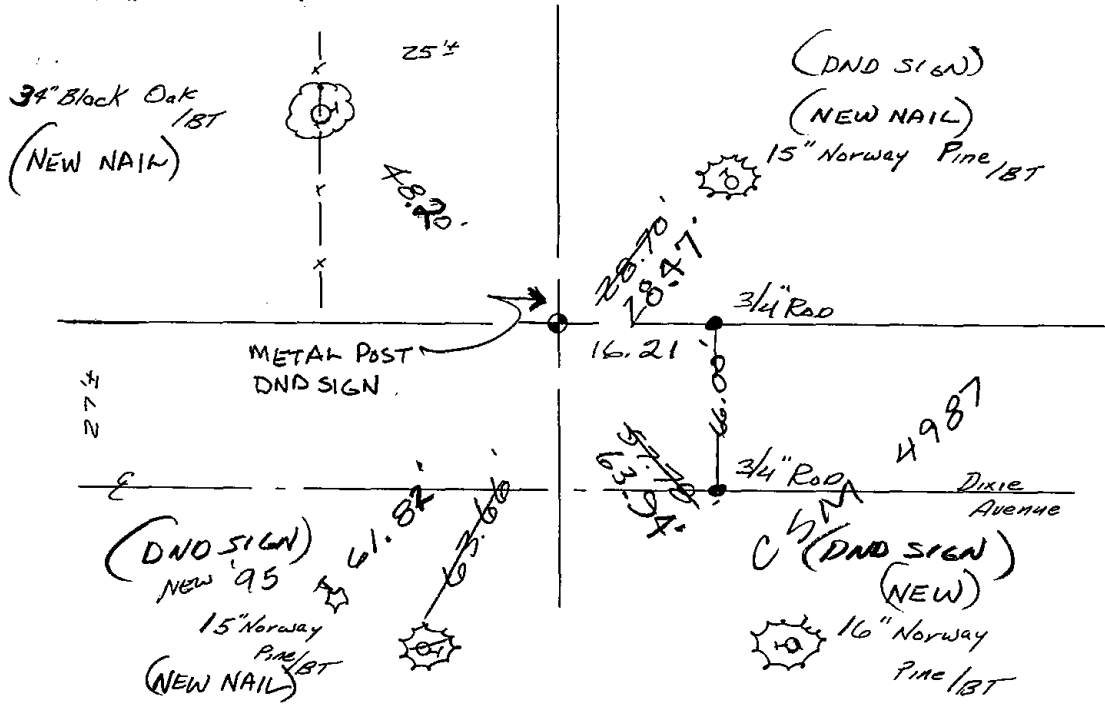
TIE SKETCH

Set monument on line between adjacent section corners and proportionate to M.C. Smith's notes of Sept., 1920 as recorded in Vol. 2 page 77 ACSR. I was unable to locate any evidence of Smith's bearing trees at this point.

ALL OK 7-2-85 DK
OK 1-29-90 KZ-SS
1 GONE-1 NEW 1-3-95 BS-SS
OK 1-10-00, JG-SS
4-NEW NAIL & DISTANCES, TOP OF MONUMENT BROKEN OFF
2-14-05, JG-DA
2-16-10 SS
