15
SECTION

ADAMS COUNTY

COUNTY CORNER NO: 58

PUBLIC LAND SURVEY MONUMENT RECORD

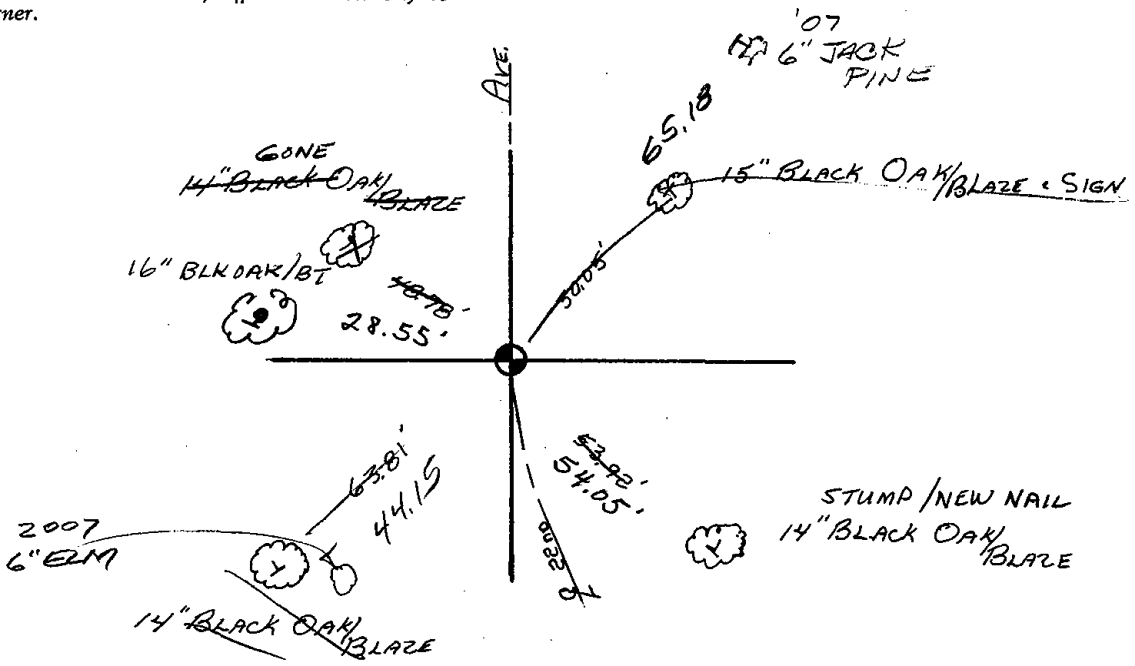
TIE SKETCH

Traversed area to locate search area. Dug with backhoe for corner evidence, could not locate. After analyzing traverse data this location was accepted. In this area there is no possession lines.
