ADAMS COUNTY COUNTY CORNER NO: 59 ROMPORTOL ID: 41804142

PUBLIC LAND SURVEY MONUMENT RECORD

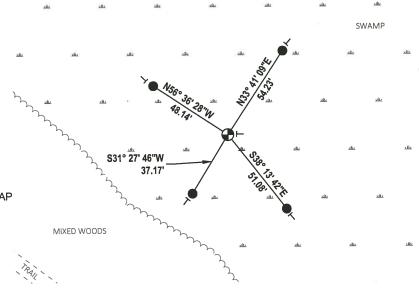
Government Land Co	orner Certificate		
Adams	County	CORNER NO.	
	on Pipe with Aluminum Cap	SECTION .	13
STATE PLANE COORDINATES:		TOWN .	
•	E	RANGE .	4
ELEVATION — M.S.L. DATUM			 7
THETA ANGLE:		ļ	
DRAWN BY: _ S. Knie	· · · · · · · · · · · · · · · · · · ·		i 7 .
BASIS FOR MONUMENT L	OCATION		
Show info such as: History of corner	, with reference to Vol.		j
and pg., dates, surveyor; exact de replaced; if location computed, by t landowner remarks, etc. (Use reverse	aned or FDM traverses	LOCATION	_
landowner remarks, etc. (Use reverse	side if necessary)	SEAL: (Indicated by 'X')	
et West Quarter Corner	equal distance and on	L. W. SCOTT S-584 WIS. RAPIDS	
ne between section corn	ers after a long search	SHIP NOONS	14.
or evidence of old corne as found and no survey i		Sea Transfer	
to round wild no barvey r	n onto area.	L. W.	
		S-584	
		WIS. RAPIDS	
		et Simmer	aris.
		MINISUR VINI	5
		DATA SHOWN HERE ON	
		CERTIFIED CORBECT:

Thanke Seo	to
4.		Registered Land Surveyor	
		DATE:	
TIE SKETCH	>		
Show at least four ties, also fence li			
and type of witness trees' and if off arrive at corner.	road - best way to		
	1 4 3 4		
	/ * *	*	
	NAIL ON NORTH SIDE NAIL	. ON SOUTH SIDE 5" MAPLE	
	en li v		
		4	_
(E-W 14 LINA	E SECTION 14-18-4 7 2.8	E-WHY LINE SECTION 13-18	}- - 4
0/452		2" X 6' I.P. # #

D. V	DNOSIGN ETT IN 18 / 3	Q FEET OUT OF GROUND	
P P	NAIL ON EAST SIDE &	\	
bil of the	OF 10" OAK	SMALL AREA OF	
	EAD NAIL STILL GOOD)	HIGH GROUND	•
0/0	3,7		
٧/٤٠ ﴿			
/ V · U	- બ		
	[3]		
	ų
