# OS RANGE ADAMS COUNTY CORNER NO: 16 ROMPORTOL ID: 41805052000

## PUBLIC LAND SURVEY MONUMENT RECORD

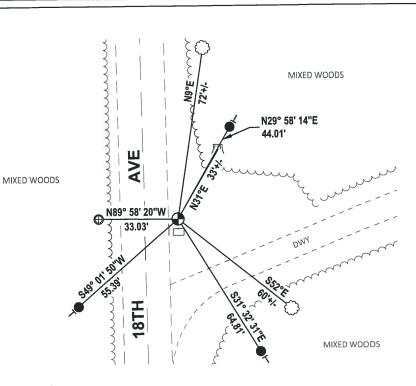
#### -TIE SKETCH

NOTE: THE CORNER FALLS 14'± EAST OF THE CENTERLINE OF 18TH AVE AND 5'± NORTH OF MAILBOX #1348.

- SET 3/4" x 18" IRON REBAR, 1.50#/FT
- FOUND 1" O.D. IRON PIPE
- FOUND HARRISON MONUMENT
- VINYL "T" POST
- WITNESS TREE
- WITNESS TREE STUMP
- MAILBOX #1348

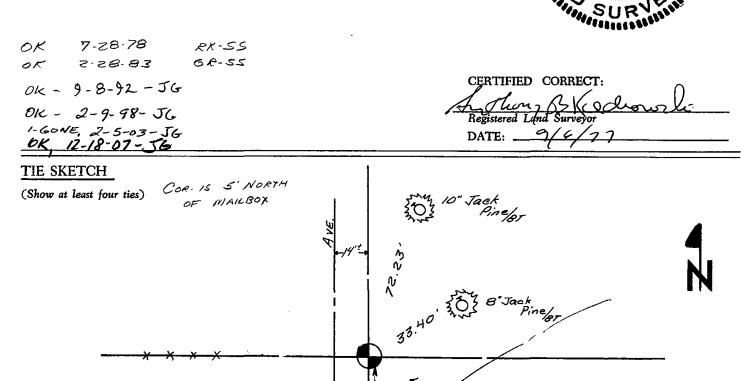
### CORNER NO. \_ ADAMS COUNTY SECTION Survey Monument Record TOWN TYPE OF MONUMENT: HARRISON STANDARD RANGE STATE PLANE COORDINATES: N. ELEVATION - M.S.L. DATUM: . THETA ANGLE: \_ FIELD BOOK: No. 54 PAGE \_ BASIS FOR MONUMENT LOCATION (Use reverse side if necessary) Show info such as: History of corner, with reference to Vol. and pg, dates, surveyor; exact description of monument replaced; if location computed, by taped or EDM traverse; landowner SEAL: Ran EDM/T2 traverse around Section 4 to determine search areas and analyze possesion. Set corner proportionate and on line between NW corner and SW corner of Section 4. Did not dig because of cut in road.
