10
SECTION

ADAMS COUNTY

COUNTY CORNER NO: 38

PUBLIC LAND SURVEY MONUMENT RECORD

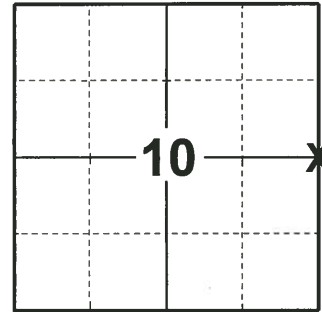
LOCATION

(INDICATE CORNER BY "X")

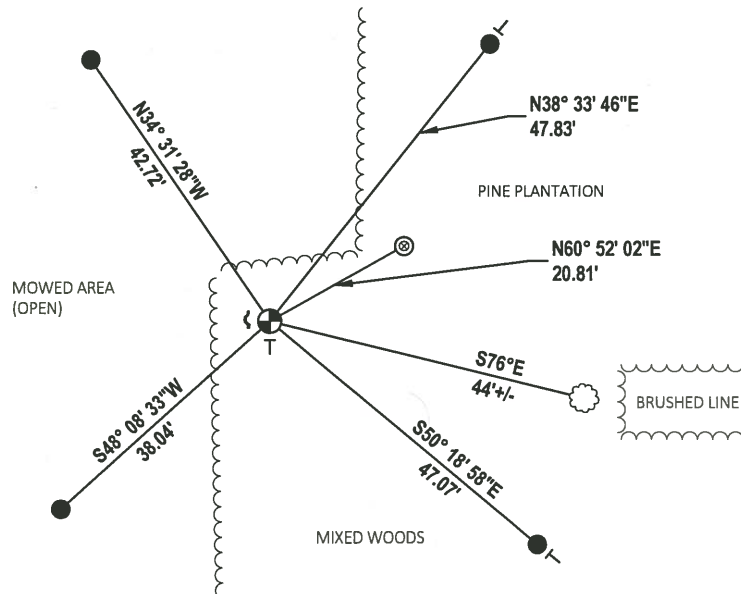
TIE SKETCH

2019 - PLS 2675 FOUND HARRISON (BROKEN-TOP) 12" BELOW THE GROUND, 1 TIE, AND 1 WITNESS. THE MONUMENT AGREES WITH THE TIE AND WITNESS. ACCEPTED THE HARRISON (BROKEN-TOP) AS THE CORNER LOCATION. SET 4 NEW TIES AND MEASURED TO THE EXISTING TIE AND WITNESS.

NOTE: TIES SET IN MOWED AREA ARE SET 12" BELOW GROUND SURFACE.

- SET 3/4" x 18" IRON REBAR, 1.50#/FT
- ⊙ FOUND 1-1/2" O.D. IRON PIPE
- ⊕ FOUND HARRISON (BROKEN-TOP) MONUMENT
- ~ STEEL FENCE POST
- VINYL "T" POST
- ⊙ WITNESS TREE

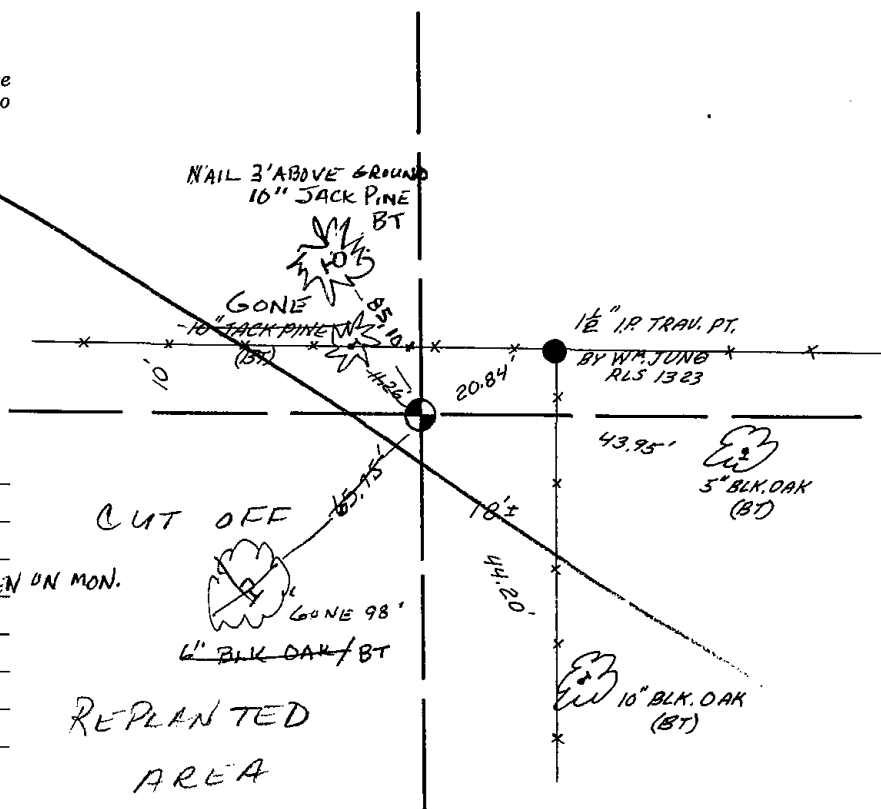
TIE SKETCH

Date	Init.	Remarks
3-14-83	GR-SS	OK
8-7-92	JG-BS	1-GONE, 2-NEW, TOP BROKEN ON MON.
3-6-98	JG	1-GONE, 4-LEFT

FD HARRISON - TOP BROKEN - SET STEEL POST IMM. WEST
05-27-08 SJS

7" NORWAY / SIGN
'08

PLACED BROKEN
PIECES OF HARRISON
AT BASE OF TREE S.B.

5' JACK PINE / SIGN IN CUT
BETWEEN PINES AND MIXED
WOODS

FD.
JUNG
1 1/2" IP

'08 SET 3/4" ROD
13' E. OF 2" BIK OAK
