10 SECTION 18 TOWN 06 RANGE

ADAMS COUNTY

COUNTY CORNER NO: 49
 ROMPORTOL ID: 4180610000

PUBLIC LAND SURVEY MONUMENT RECORD

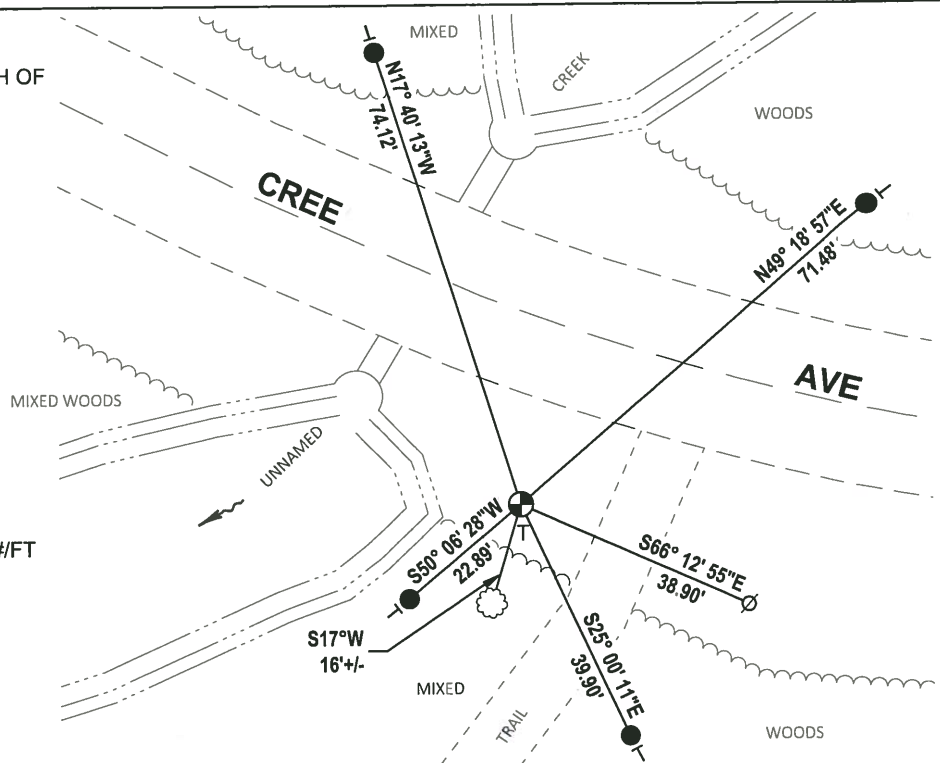
- TIE SKETCH

2019 - PLS 2675 FOUND A HARRISON MONUMENT FLUSH WITH THE GROUND SURFACE AND 2 WITNESSES. THE MONUMENT AGREES WITH THE EXISTING WITNESSES. ACCEPTED THE HARRISON MONUMENT AS THE CORNER LOCATION. SET 4 NEW TIES. MEASURED TO THE TIES AND WITNESSES.

NOTE: THE CORNER FALLS 28'± SOUTH OF THE CENTERLINE OF CREE AVE.

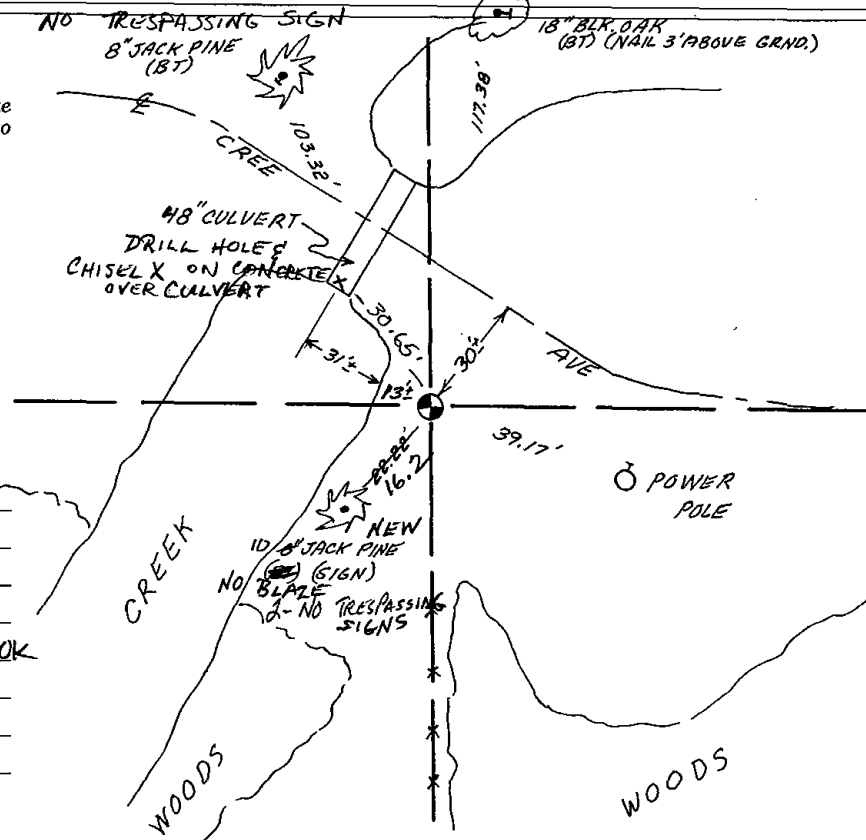
TIE SKETCH

This corner was set at the intersection of the ancient fenceline to the south and the centerline extended from the east. Previous excavation in the area to alter the course of the creek and install culverts made it impossible to find any evidence when digging with a backhoe. A T2/EDM traverse of Sections 11 and 10 verified that the location matched original distances to adjacent corners well.

Date	Init.	Remarks
3-4-83	SS	OK
2-23-80	GR-SS	"
8-7-92	JG-BS	1-GONE, 2-NEW, MON. OK
2-25-98	JG	OK
1-3-03	ML	OK
11-27-07	3L	OK
