PUBLIC LAND SURVEY MONUMENT RECORD

TYPE OF MONUMENT: HARRISON (BROKEN-TOP)
 ADAMS COUNTY COORDINATES, NAD 83 (2007)

Survey Monument Record

CORNER NO. 374
 SECTION 16
 TOWN 18 N
 RANGE 6 E

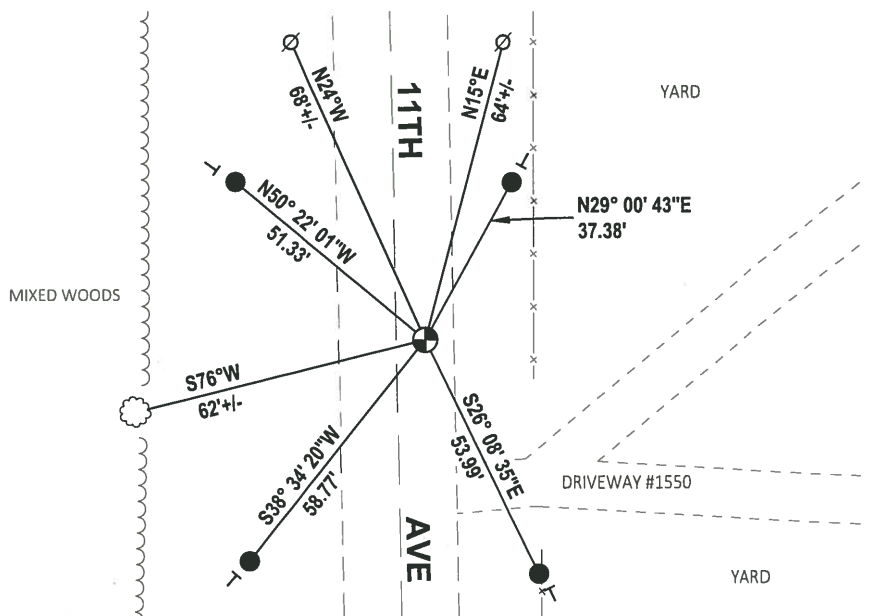
TIE SKETCH

2019 - PLS 2675 FOUND HARRISON (BROKEN-TOP) 6" BELOW THE ROAD SURFACE AND 3 WITNESSES. THE MONUMENT AGREES WITH THE EXISTING WITNESSES. ACCEPTED THE HARRISON (BROKEN-TOP) AS THE CORNER LOCATION. SET 4 NEW TIES AND MEASURED TO THE EXISTING WITNESSES AND TIES.

NOTE: THE CORNER FALLS 6'± EAST OF THE CENTERLINE OF 11TH AVE.

- SET 3/4" x 18" IRON REBAR, 1.50#/FT
- ⊕ FOUND HARRISON (BROKEN-TOP) MONUMENT
- ⊗ WITNESS POWER POLE
- ⊥ VINYL "T" POST
- ☁ WITNESS TREE

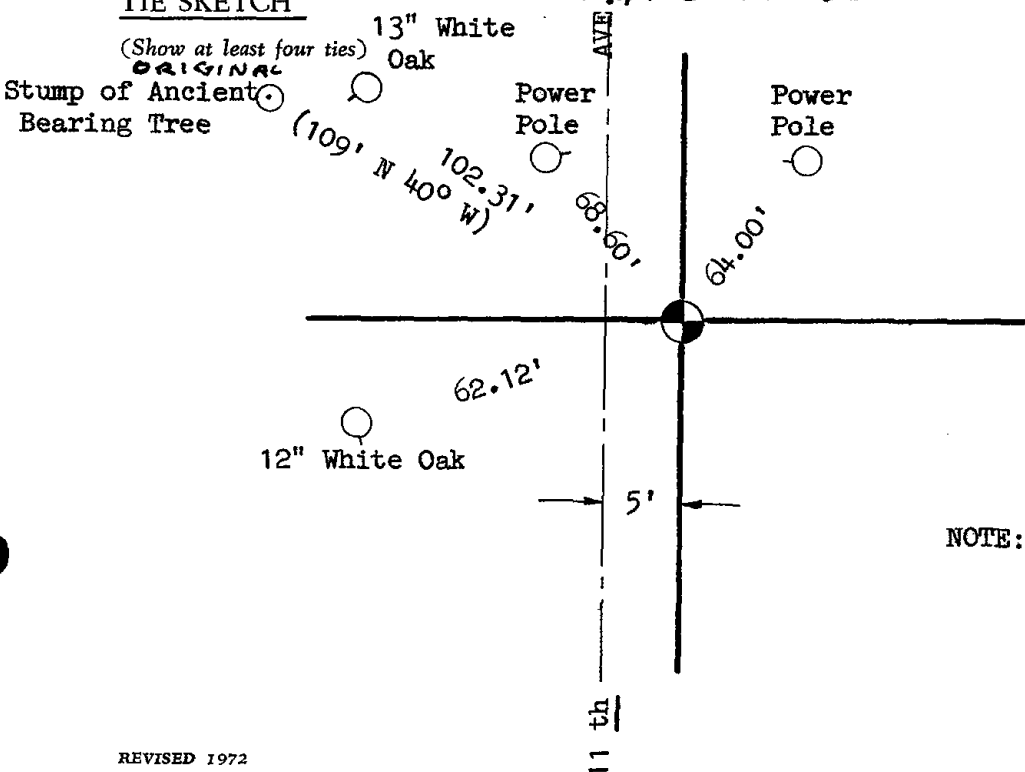
TIE SKETCH

Excavation with backhoe yielded 1/2 inch by 2 1/4 inch iron pipe along side of machinery bracket weighting approximately 5 pounds.

This location was indicated to be the correct location of the Quarter corner by Edward Viktora, age approx. 75, a lifelong resident of the nearby farm. He indicated that his father had replaced the stone that had been at this location. He also pointed out the location of the original rotting bearing tree stump with the writing still ledgible.

NOTE: All ties to nail and disc.
