PUBLIC LAND SURVEY MONUMENT RECORD

TYPE OF MONUMENT: SURVEY NAIL
 ADAMS COUNTY COORDINATES, NAD 83 (2007)

Government Land Corner Certificate

CORNER NO. 67
SECTION 22
TOWN 18
RANGE 6

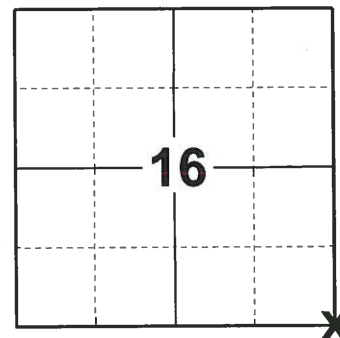
LOCATION

(INDICATE CORNER BY "X")

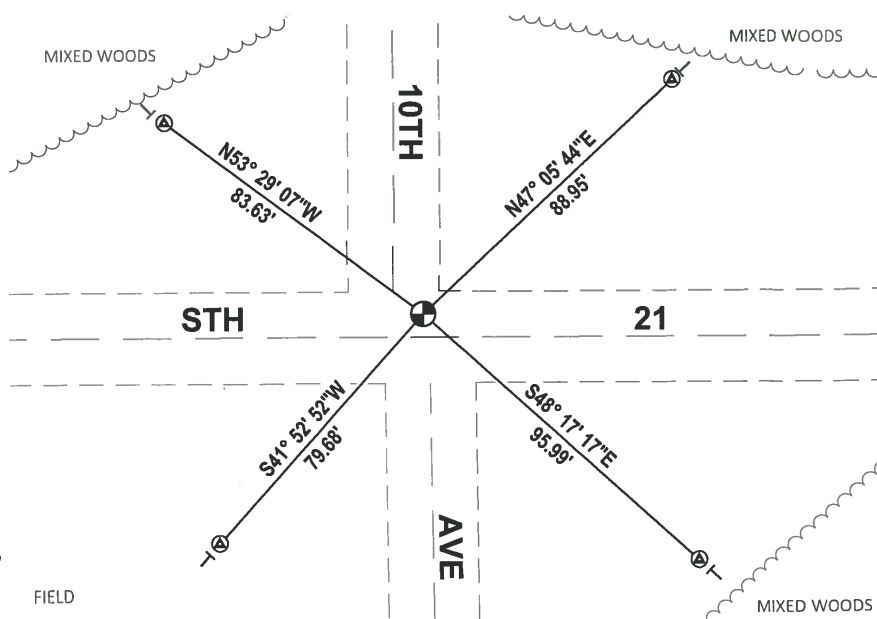
TIE SKETCH

2019 - PLS 2675 FOUND SURVEY NAIL IN THE ROAD SURFACE AND 4 TIES, REMOVED THE SURVEY NAIL AND FOUND NO ADDITIONAL EVIDENCE OF ANY ADDITIONAL MONUMENTS BELOW. THE SURVEY NAIL LOCATION AGREES WITH ALL 4 TIES. ACCEPTED THE SURVEY NAIL AS THE CORNER LOCATION. RESET AND MEASURED TO THE EXISTING TIES.

NOTE: THE CORNER FALLS 6'± NORTH OF THE CENTERLINE OF STH 21.

- ⊕ FOUND BERNTSEN SDR103 W/BRONZE CAP
- ⊕ FOUND SURVEY NAIL MONUMENT
- ⊖ VINYL "T" POST

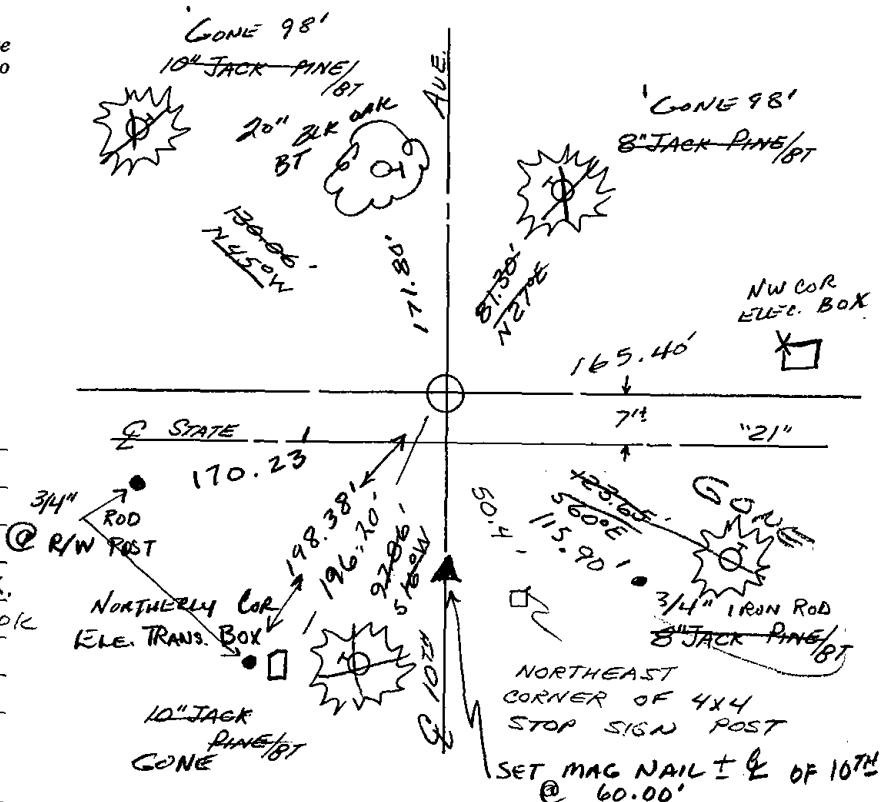
TIE SKETCH

Set by retracing survey by M.C. Smith done in 1911 located in the SW Quarter of Section 15-18-6.

Date	Init.	Remarks
3-4-83	SS	1 NEW TIE
2-2-88	GR-SS	OK
7-30-92	JG-RS	1-GONE, 1-NEW, MON. OK.
3-31-98	JG-SS	3-GONE, 3-NEW, MON. OK.
1-2-03	Mh	OK
1-22-03	JG	2-NEW
12-20-07	SG-SS	OK
