## PUBLIC LAND SURVEY MONUMENT RECORD

TYPE OF MONUMENT: BERNTSEN SNM1 SURVEY NAIL  
ADAMS COUNTY COORDINATES, NAD 83 (2007)

ADAMS COUNTY

Survey Monument Record

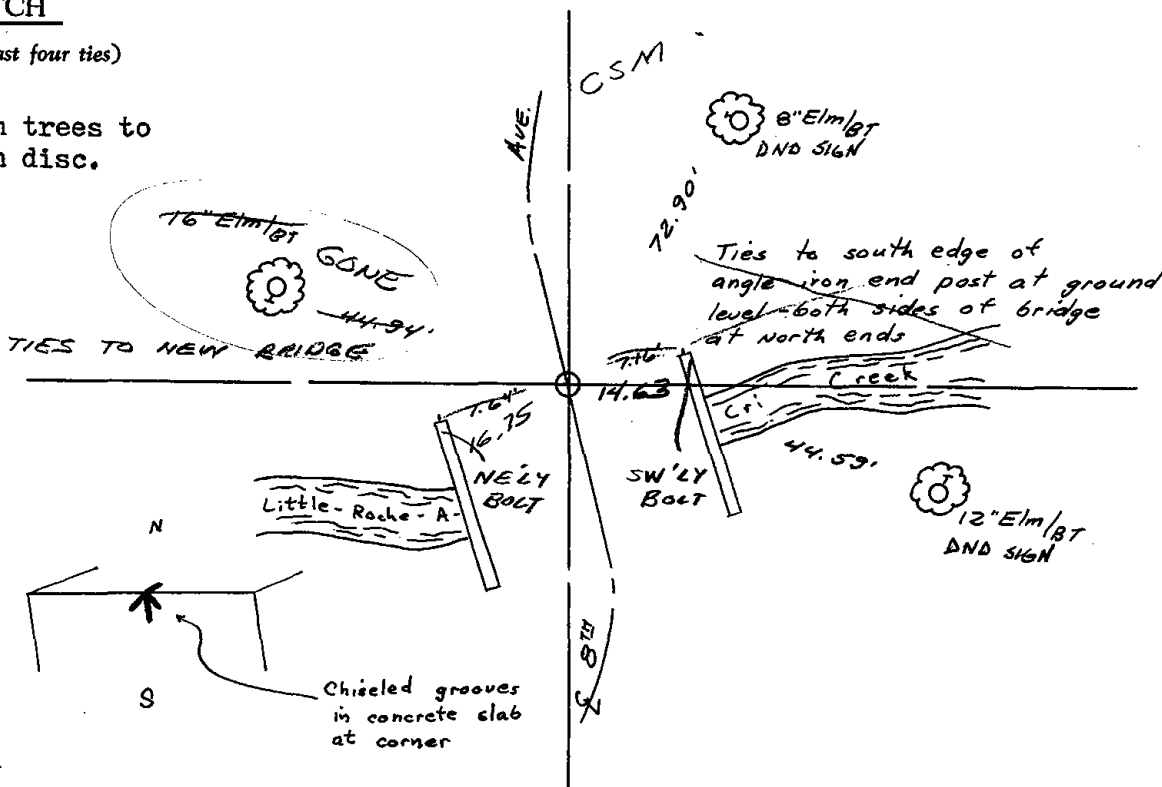
TIE SKETCH

Ran EDM/transit traverse around Section 25 and to the adjacent corners to determine search areas.

Did not excavate because corner search area fell within the bridge construction area.

Set corner by single proportional measure between adjacent section corners.

Ties in trees to nail in disc.

3-2-83 - SS - 1 TIE GONE - NOTHING AVAILABLE

FO P.K. - ADD 2 NEW TIES 4-23-98 JG-SS
