PUBLIC LAND SURVEY MONUMENT RECORD

Government Land Corner Certificate

CORNER NO. 75
 SECTION 20
 TOWN 18
 RANGE 7

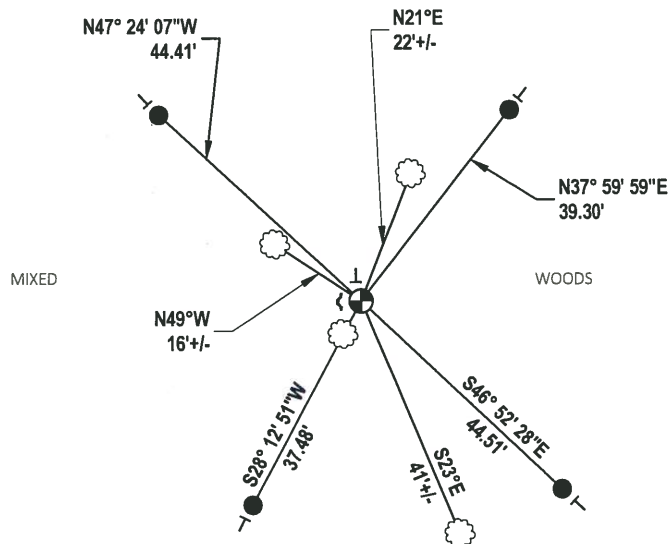
- TIE SKETCH

2020 - PLS 2675 FOUND HARRISON MONUMENT FLUSH WITH THE GROUND AND 4 WITNESS TREES. THE MONUMENT AGREES WITH ALL WITNESS TREES. ACCEPTED THE HARRISON MONUMENT AS THE CORNER LOCATION. SET 4 NEW TIES AND MEASURED TO THE EXISTING WITNESS TREES.

NOTE: THE WITNESS TREE TO THE SW IS S29°W, 6'± FROM THE HARRISON MONUMENT.

- SET 3/4" x 18" IRON REBAR, 1.50#/FT
- ⊕ FOUND HARRISON MONUMENT
- ┌ STEEL FENCE POST
- └ VINYL "T" POST
- ☁ WITNESS TREE
