ADAMS COUNTY

COUNTY CORNER NO: 126

PUBLIC LAND SURVEY MONUMENT RECORD

Government Land Corner Certificate

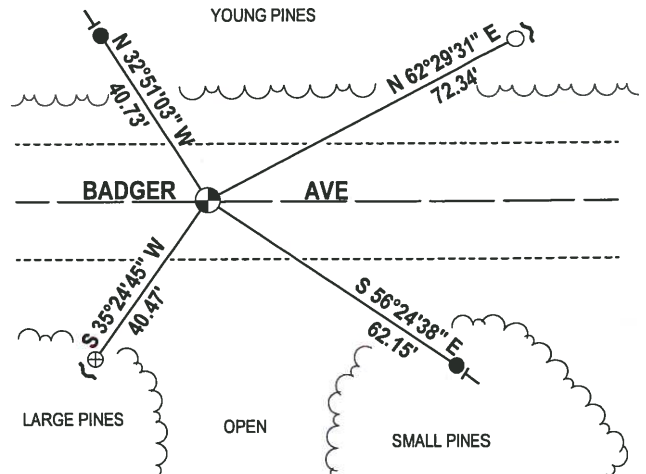
- TIE SKETCH

2018 - PLS 2994 FOUND A HARRISON MONUMENT WITH A BROKEN-TOP 30" BELOW THE ROAD SURFACE, 1 TIE AND 1 PROPERTY IRON. THE MONUMENT AGREES WITH THE EXISTING TIE. ACCEPTED THE HARRISON MONUMENT WITH A BROKEN-TOP AS THE CORNER LOCATION. SET 2 NEW TIES AND MEASURED TO THE TIES AND PROPERTY IRON.

- 3/4" x 18" IRON REBAR SET, 1.50#/FT
- 3/4" IRON ROD FOUND
- ⊕ 2-3/8" O.D. IRON PIPE FOUND
- ⊙ HARRISON (BROKEN-TOP) FOUND
- ↗ STEEL FENCE POST
- ↖ VINYL "T" POST

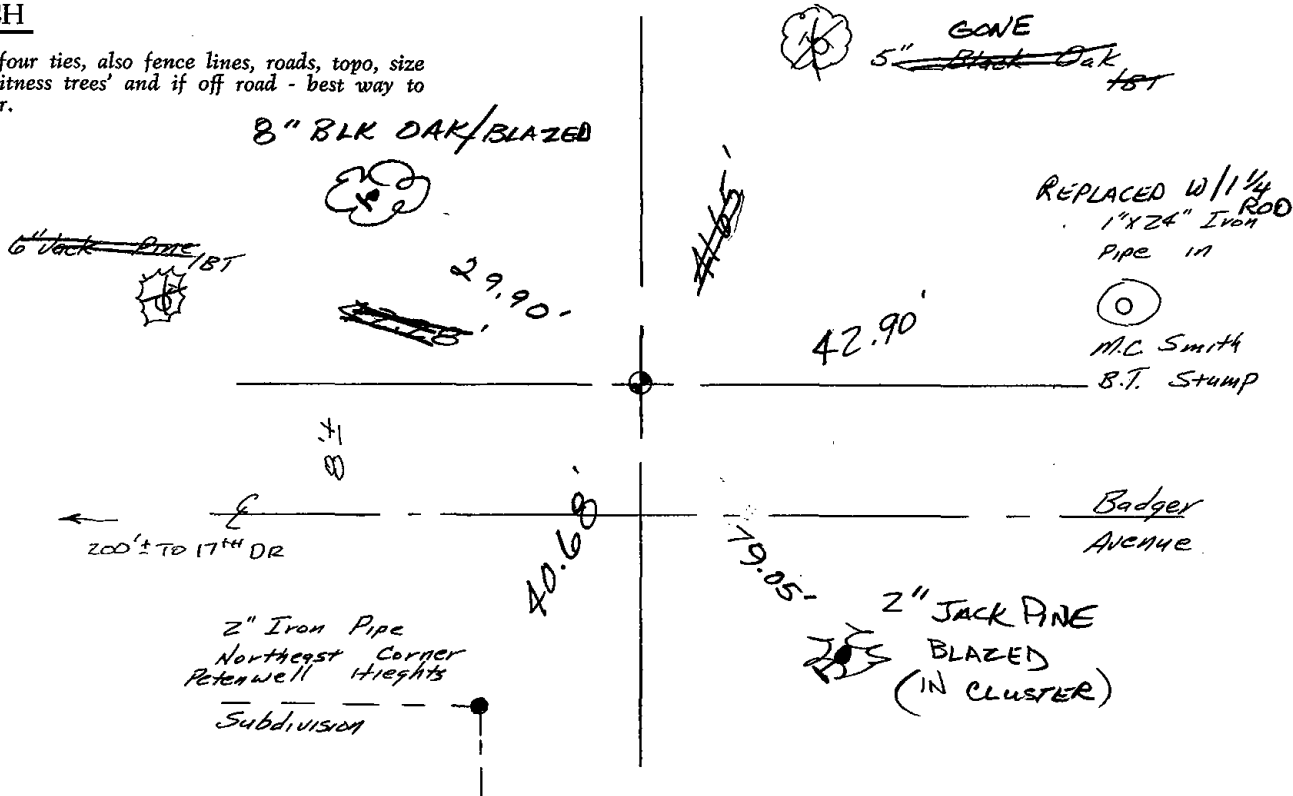
TIE SKETCH

Set corner from the rotted stump of a black oak bearing SEAL: tree by M. C. Smith, as recorded in Adams County Surveyor Records V. 2, p. 48. This fit extremely well with the stone found by A. B. Kiedrowski at the NE corner of Section 4. It also fit well with the 2" iron pipe at the NW corner of the NE $\frac{1}{4}$ of the NW $\frac{1}{4}$ referenced by Adams County Certified Survey Map by Edmond Novak RLS 561. No excavation was made at this point as the corner falls in the bottom of the north ditch of Badger Avenue. This corner does not fall on the east line of Petenwell Highlands in the NE $\frac{1}{4}$ of the NW $\frac{1}{4}$. There is no mention of any corner used at the N $\frac{1}{2}$ corner for this plat.
