PUBLIC LAND SURVEY MONUMENT RECORD

TYPE OF MONUMENT: HARRISON (BROKEN-TOP)
 ADAMS COUNTY COORDINATES, NAD 83 (1905)

ADAMS COUNTY

Survey Monument Record

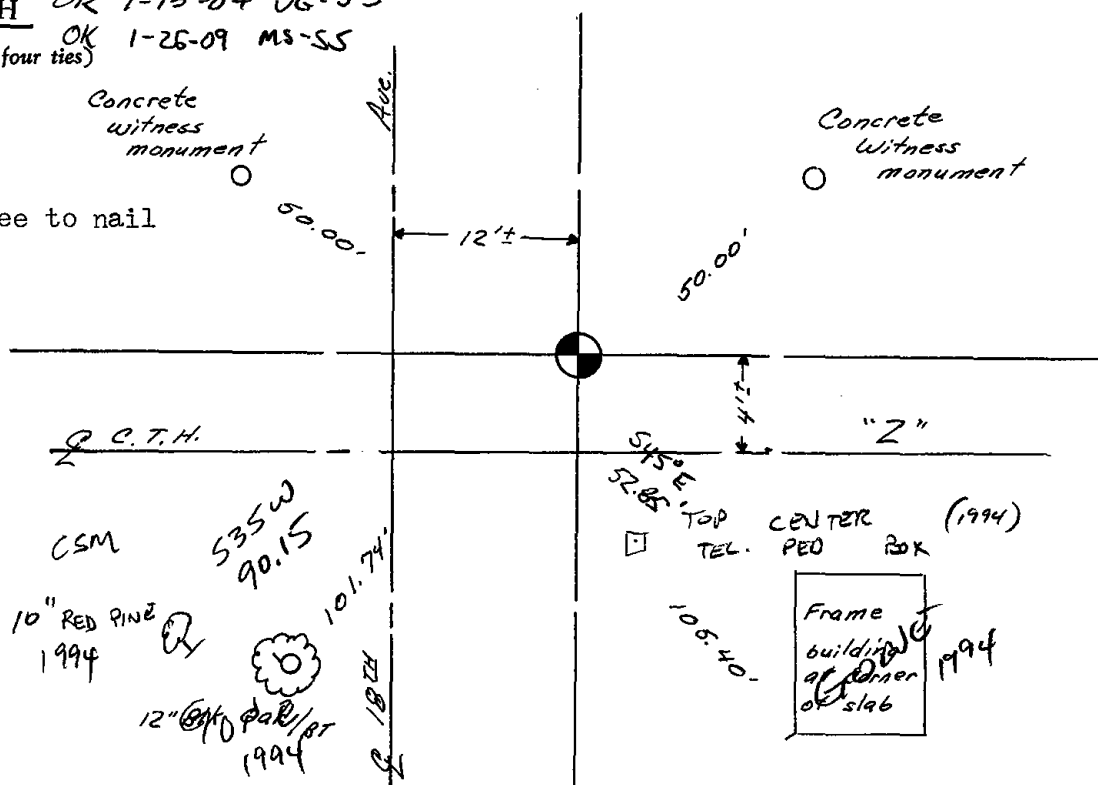
TIE SKETCH OK 1-15-04 JG-JS

(Show at least four ties) OK 1-26-09 MS-SS

NOTE

Tie in tree to nail in disc.
