PUBLIC LAND SURVEY MONUMENT RECORD

TYPE OF MONUMENT: HARRISON (BROKEN-TOP)
 ADAMS COUNTY COORDINATES, NAD 83 (1905)

Government Land Corner Certificate

CORNER NO. 50
 SECTION 11
 TOWN 19
 RANGE 5

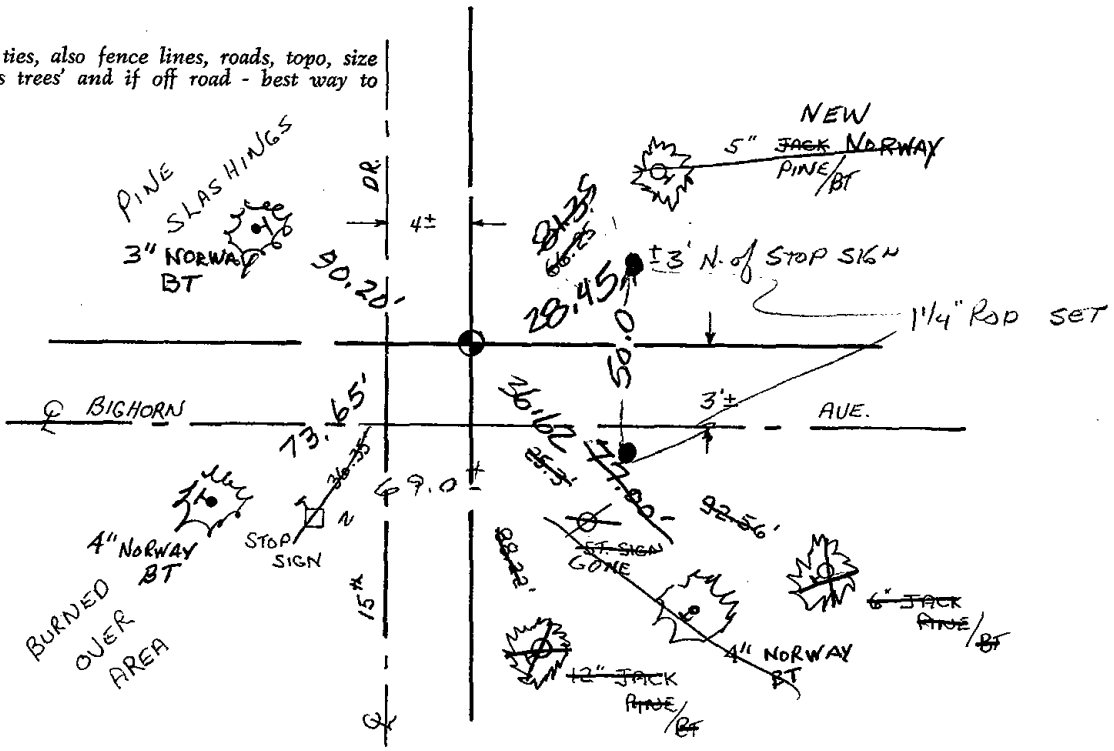
TIE SKETCH

Scraped entire intersection of ~~16th Ave and fire lane~~. Found bottom 4" of 3" dia burned wood post. Replaced same with Harrison. Location verified by EDM traverse. No records of resurveys.

Three ties were found destroyed, so new steel posts were installed and a new sketch is located on back of this sheet. 4-17-84 DK-SS

4-NEW TIES, TOP BROKEN OFF MON., 1-02-03-JG
2 NEW TIES - 1 1/4" RODS - 4-7-09 SS
