34
SECTION

ADAMS COUNTY

COUNTY CORNER NO: 118

PUBLIC LAND SURVEY MONUMENT RECORD

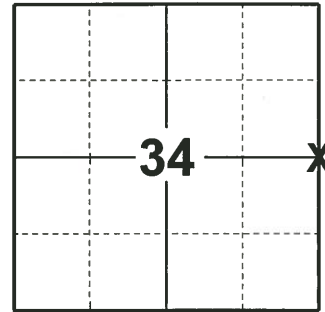
- TIE SKETCH

NOTE: THE CORNER FALLS 2'± EAST OF 16TH AVE CENTERLINE.

2019 - PLS 2675 FOUND HARRISON (BROKEN-TOP) MONUMENT 6"± BELOW THE ROAD SURFACE (18"± UNDER WATER) AND 1 GOOD TIE (SW WAS BENT). ALL WITNESSES HAVE BEEN DESTROYED BY LOGGING AND FIELD CLEARING. THE NE TIE FIT WELL WITH THE MONUMENT. ACCEPTED THE HARRISON (BROKEN-TOP) MONUMENT AS THE CORNER LOCATION. SET 2 NEW TIES, STRAIGHTENED THE SW TIE AND MEASURED TO THE EXISTING TIES.

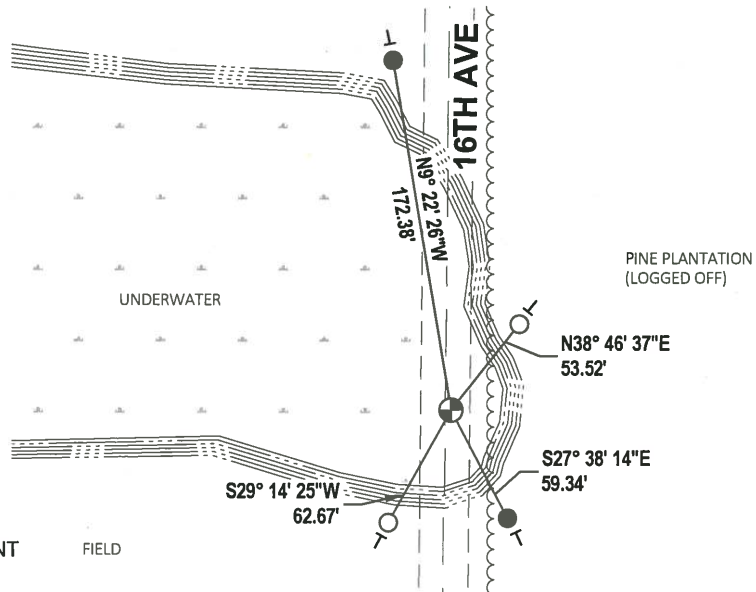
- SET 3/4" x 18" IRON REBAR, 1.50#/FT
- FOUND 3/4" IRON ROD
- ⊕ FOUND HARRISON (BROKEN-TOP) MONUMENT
- VINYL "T" POST

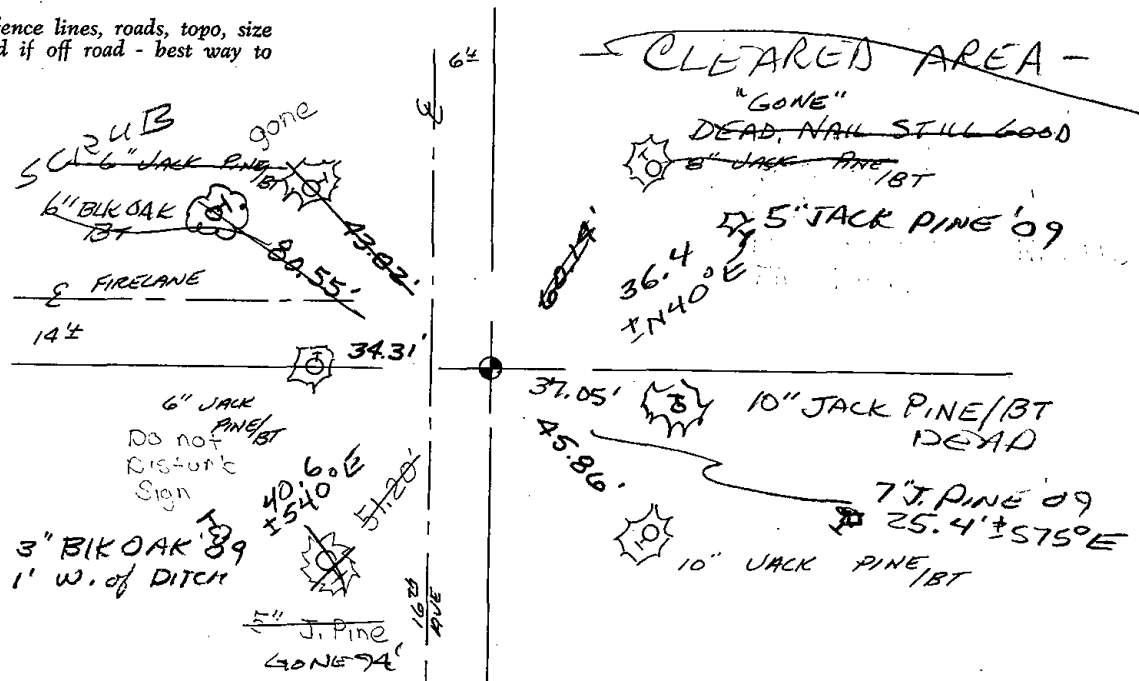
TIE SKETCH

Set corner equidistant and on line between adjacent section corners. No evidence of any previous monumentation was found while excavating with backhoe. No record of any monumentation subsequent to the original was found.

- 1 new 3-21-84 SS
- OK 11-22-88 G.R.-J.R.
- OK 2-14-94 CR-JG
- 2-NEW, MON. OK, 2-10-98-JG
- 1-GONE, 4-LEFT, 1-02-03-JG

3 NEW TIES 4-6-09-SS
