PUBLIC LAND SURVEY MONUMENT RECORD

TYPE OF MONUMENT: HARRISON
 ADAMS COUNTY COORDINATES, NAD 83 (2007)

CORNER NO. 6
 SECTION 5
 TOWN 19
 RANGE 6

CORNER NO. 905 ³
SECTION 5
TOWN 19
RANGE 6

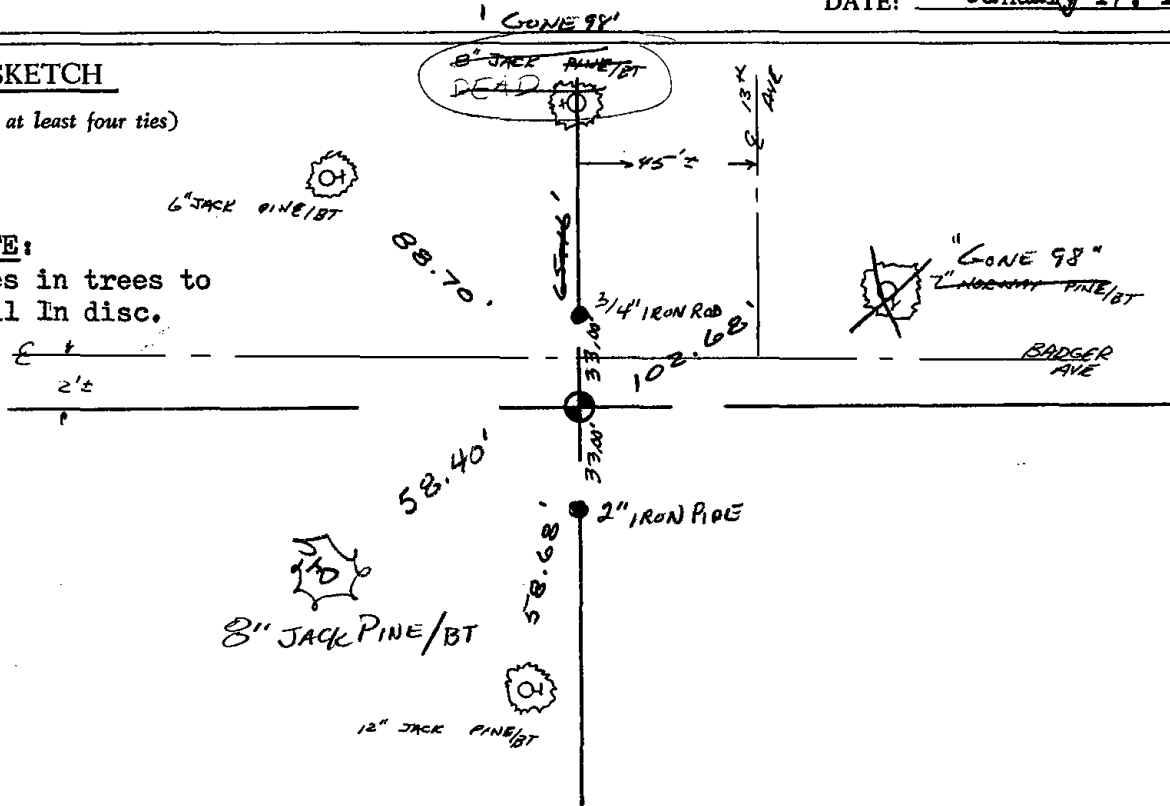
TIE SKETCH

Ran EDM/transit traverse around Sections 4, 5 and parts of 3 and 6 to determine search areas, but excavation with backhoe yielded no evidence of the original corner or any remonumentation.

Set corner proportional to original notes between the Northwest corner of Section 6 and the Northeast corner of Section 4.

Ties in trees to nail in disc.
