32 SECTION 20 TOWN 06 RANGE

# ADAMS COUNTY

COUNTY CORNER NO: 125  
ROMPORTOL ID: 42006320000

## PUBLIC LAND SURVEY MONUMENT RECORD

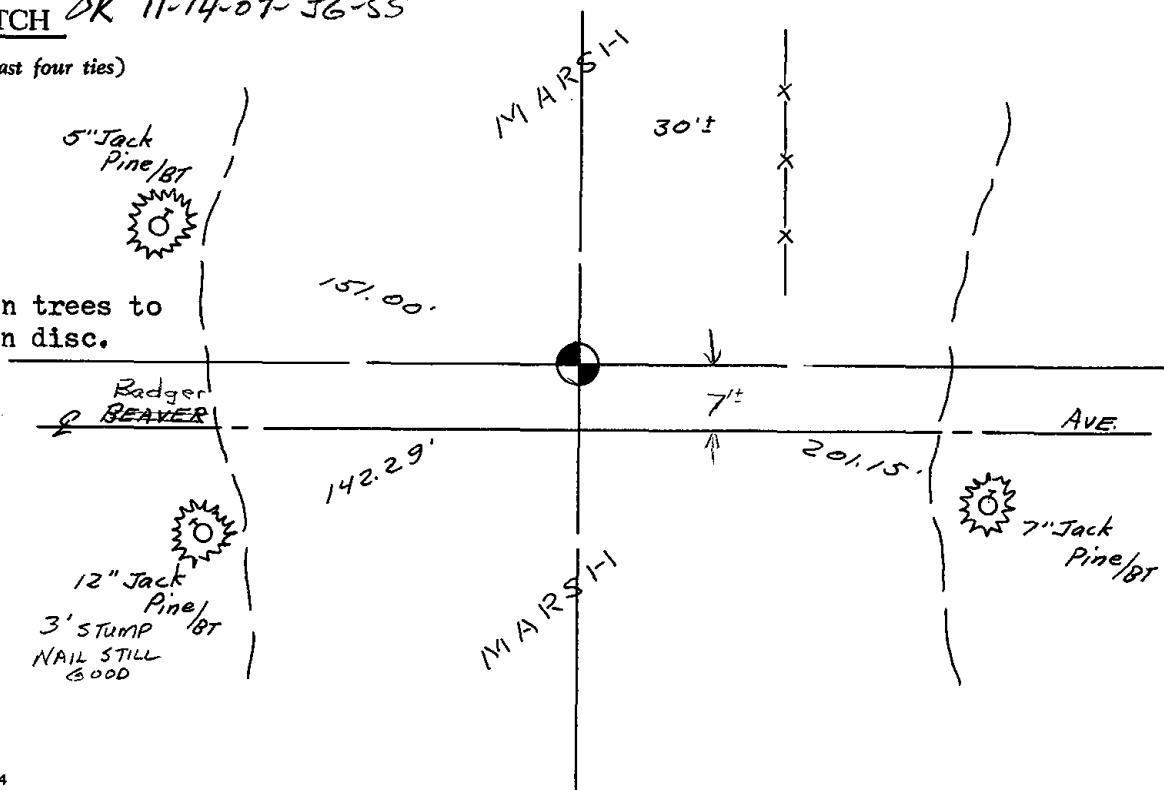
TIE SKETCH *DK 11-14-07 JG-85*

Ran EDM/transit traverse around Sections 4, 5 and parts of 3 and 6 to determine search areas.

Could find no evidence of the original corner or any remonumentation.

Set corner proportional to original notes between the Northwest corner of Section 6 and the Northeast corner of Section 4.

Ties in trees to nail in disc.
