04 SECTION 19 TOWN 06 RANGE

ADAMS COUNTY

COUNTY CORNER NO: 27
ROMPORTOL ID: 41906040000

PUBLIC LAND SURVEY MONUMENT RECORD

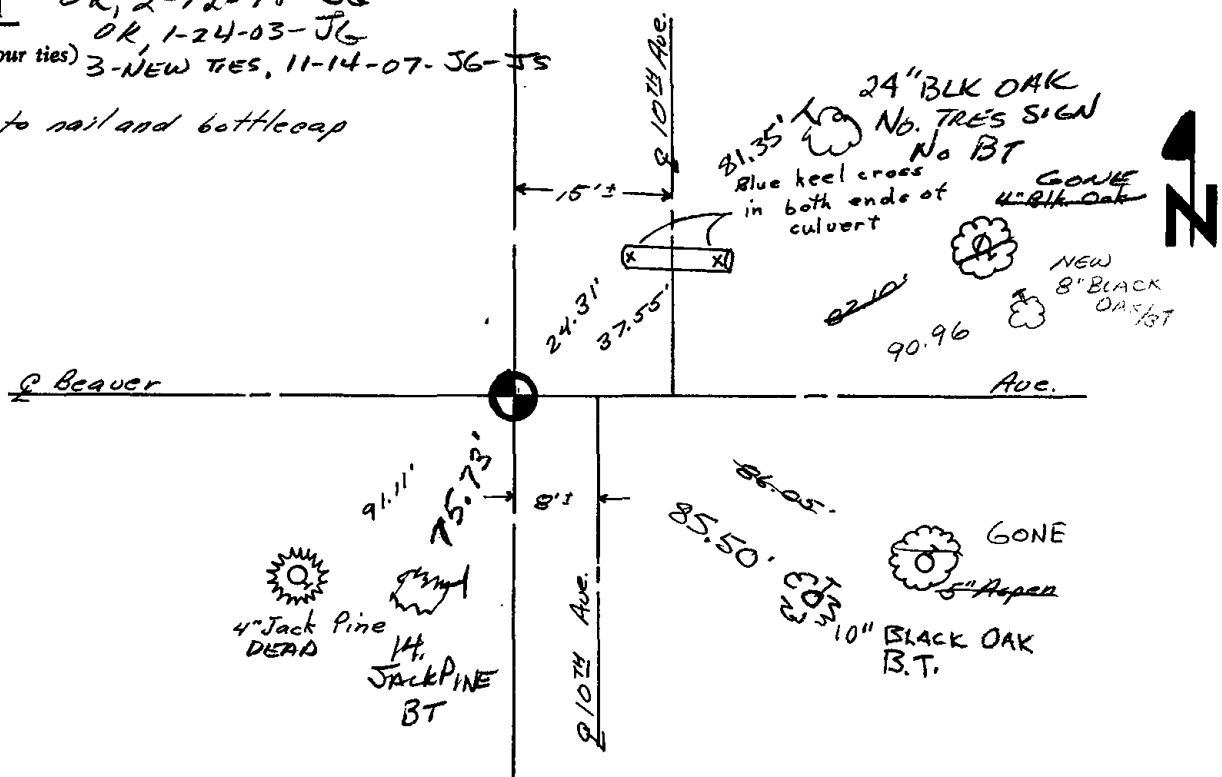
TIE SKETCH OK, 2-12-98-JG

(Show at least four ties) OK, 1-24-03-JG
3-NEW TIES, 11-14-07-JG-SS

Note: ties to nail and bottlecap
