ADAMS COUNTY

COUNTY CORNER NO: 84

PUBLIC LAND SURVEY MONUMENT RECORD

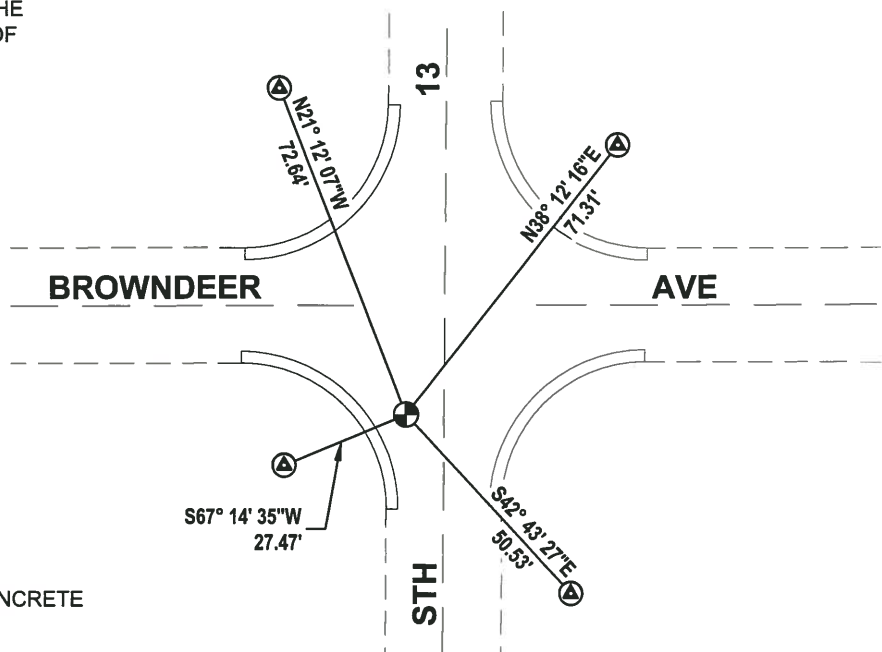
TIE SKETCH

2018 - PLS 2675 FOUND A SURVEY NAIL IN THE ROAD SURFACE AND 4 TIES. REMOVED THE SURVEY NAIL AND FOUND NO EVIDENCE OF ANY ADDITIONAL MONUMENTS. THE SURVEY NAIL LOCATION AGREES WITH THE EXISTING TIES. ACCEPTED THE SURVEY NAIL LOCATION AS THE CORNER LOCATION. RE-SET THE SURVEY NAIL IN IT'S LOCATION AND RE-MEASURED TO THE EXISTING TIES.

NOTE: THE CORNER FALLS 8'± WEST OF THE CENTERLINE OF STH 13 AND 23'± SOUTH OF THE CENTERLINE OF BROWND EER AVE.

- FOUND WISDOT ALUMINUM CAP IN CONCRETE
- ⊕ RE-SET SURVEY NAIL

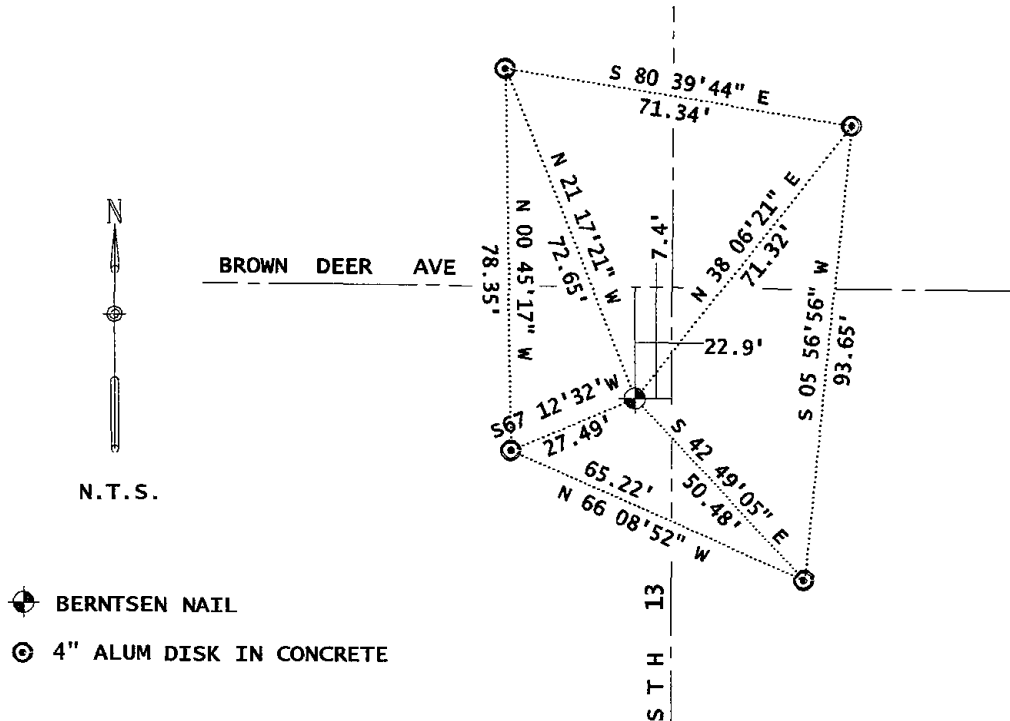
TIE SKETCH

Found RR spike on 9-8-2008, prior to 2008 Resurfacing Project. Set new reference monuments (4" Alum. Disks set in concrete) on 10-2-2008. Re-set section corner on 11-3-2008 and measured Ties.

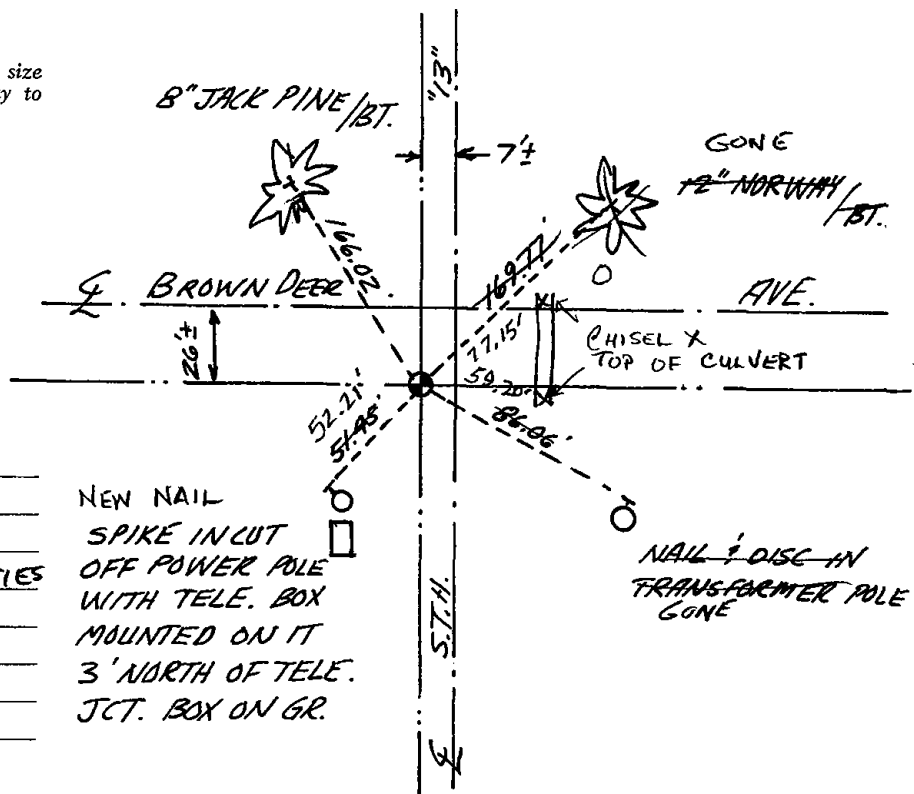
TIE SKETCH

Set equidistant and on line between adjacent section corners. No excavation was attempted due to search area location in STH "13". No evidence of any previous monumentation or witnesses was found.

Date	Init.	Remarks
3-11-83	GR-SS	OK
8-19-92	JG-TS	2-TIES GONE, 2-NEW TIES
4-24-98	JG-SS	OK
5-19-03	JG-SS	OK
11-14-07	JG-SS	OK

NEW NAIL
 SPIKE INCUT
 OFF POWER POLE
 WITH TELE. BOX
 MOUNTED ON IT
 3' NORTH OF TELE.
 JCT. BOX ON GR.

NAIL & DISC IN
 TRANSFORMER POLE
 GONE
