OT ADAMS COUNTY COUNTY COUNTY CORNER NO: 17

PUBLIC LAND SURVEY MONUMENT RECORD

HARRISON (BROKEN-TOP)

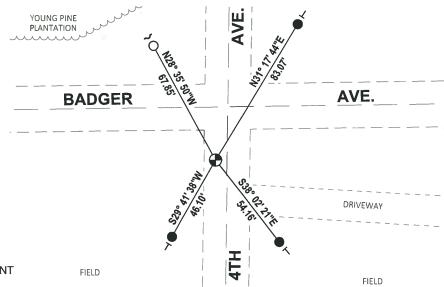
- TIE SKETCH

2019 - PLS 2675 FOUND HARRISON (BROKEN-TOP) 4" BELOW THE ROAD SURFACE AND 1 TIE. THE MONUMENT AGREES WITH THE EXISTING TIE. ACCEPTED THE HARRISON (BROKEN-TOP) AS THE CORNER LOCATION. SET 3 NEW TIES AND MEASURED TO THE EXISTING TIE.

NOTE: THE CORNER LANDS ±28' SOUTH OF BADGER AVE. CENTERLINE AND ±6' WEST OF 4TH AVE. CENTERLINE.
