# ADAMS COUNTY

## PUBLIC LAND SURVEY MONUMENT RECORD

08 SECTION 19 TOWN 07 RANGE

COUNTY CORNER NO: 36  
 ROMPORTOL ID: 41907082000

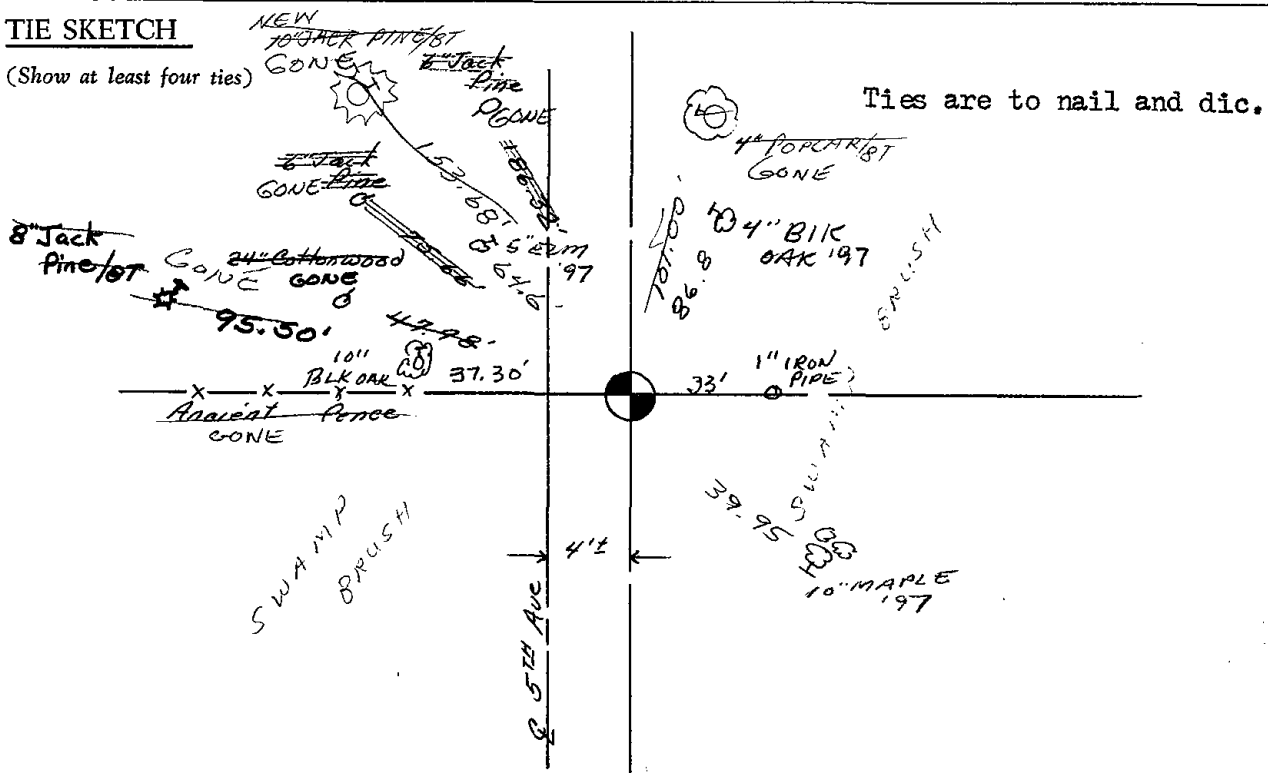
**TIE SKETCH**

Set on a straight line equidistant between section corners. Excavated area with backhoe, found nothing.

CORNER O.K.	6-14-77	SK-SS
TOP BROKEN	3-18-82	GR-SS
OK	3-30-97	GR-SS
"	12-5-91	KZ-JG
3 NEW TIES	3-18-97	JG-SS
OK	1-03-02 JG	OK, 9-24-07-JG
