# OT RANGE ADAMS COUNTY COUNTY CORNER NO: 49

ROMPORTOL ID: 41907100000

# PUBLIC LAND SURVEY MONUMENT RECORD

## Government Land Corner Certificate

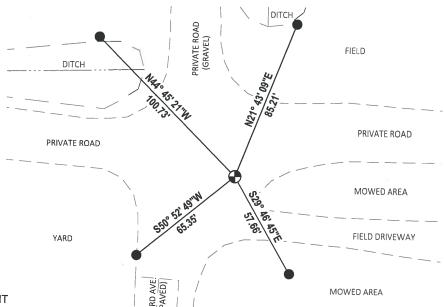
#### - TIE SKETCH

2019 - PLS 2675 FOUND HARRISON (BROKEN-TOP) 20" BELOW THE ROAD SURFACE AND DID NOT RECOVER ANY TIES OR WITNESSES. ACCEPTED HARRISON (BROKEN-TOP) AS THE CORNER LOCATION AND SET 4 NEW TIES.

NOTE: ALL REBAR SET 18"± DOWN.

SET 3/4" x 18" IRON REBAR, 1.50#/FT

FOUND HARRISON (BROKEN-TOP) MONUMENT

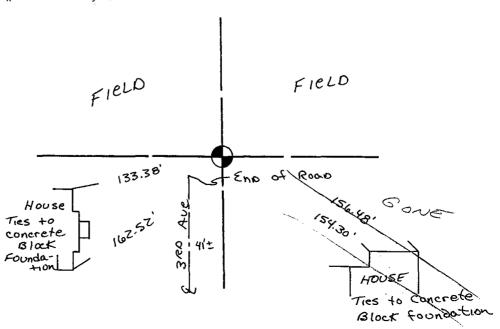
### TIE SKETCH

This corner was set by double proportionate measure.

DATE	BY WHOM	REMARKS		
3-30-87	GR-55	House S.E. G.	NE - No TIES	NURICABER COR OK
1-8-92	GR-55 JB-KZ	Ji	7 t	COR OK
-
