OB ADAMS COUNTY

COUNTY CORNER NO: 5

ROMPORTOL ID: 42006059000

PUBLIC LAND SURVEY MONUMENT RECORD

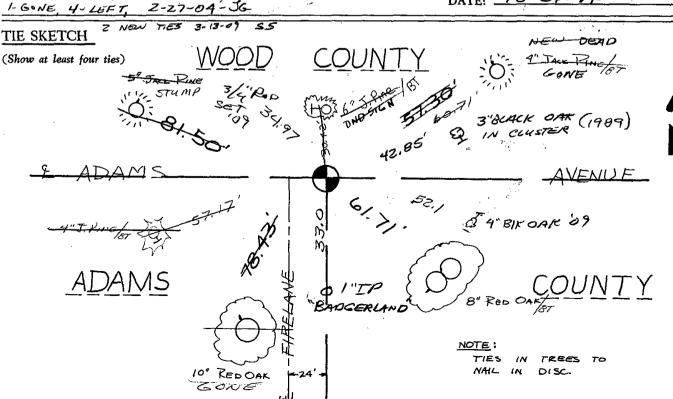
- TIE SKETCH

2017 - PLS 2994 FOUND EXISTING HARRISON WITH A BROKEN TOP 18 INCHES BELOW THE ROAD SURFACE, ONE TIE AND ONE WITNESS TREE. THE HARRISON AGREES WITH THE EXISTING WITNESS TREE AND TIE. ACCEPTED HARRISON AND SET 4 NEW TIES.

● 3/4" x 18" IRON REBAR SET, 1.50#/FT ○ 1" OD IRON PIPE FOUND

HARRISON FOUND

VINYL "T" POST

WITNESS TREE FOUND
