06 RANGE ADAMS COUNTY CORNER NO: 19 ROMPORTOL ID: 42006022000

PUBLIC LAND SURVEY MONUMENT RECORD

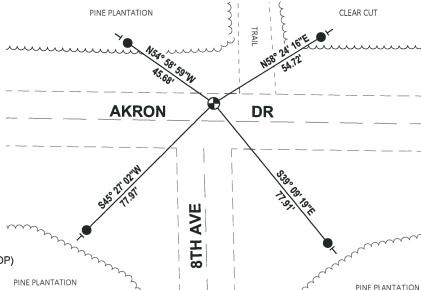
-TIE SKETCH

2018 - PLS 2994 FOUND A HARRISON MONUMENT WITH A BROKEN-TOP 18" BELOW THE ROAD SURFACE. FOUND NO EVIDENCE OF ANY OF THE WITNESSES. ACCEPTED THE HARRISON MONUMENT WITH A BROKEN-TOP AS THE BEST EVIDENCE OF THE CORNER LOCATION. SET 4 NEW TIE AND MEASURED TO THE TIES.

NOTE: THE CORNER FALLS 8'± NORTH OF THE CENTERLINE OF AKRON DR AND 5'± EAST OF THE CENTERLINE OF 8TH AVE.

- SET 3/4" x 18" IRON REBAR, 1.50#/FT
- FOUND HARRISON MONUMENT (BROKEN-TOP)
- VINYL "T" POST
