PUBLIC LAND SURVEY MONUMENT RECORD

N 1/4 CORNER OF SECTION 18, TOWNSHIP 20N,
RANGE 6E, TOWN OF ROME, ADAMS COUNTY,
WISCONSIN.

CORNER	SECTION	TWP	RANGE
N 1/4	18	20N	6E

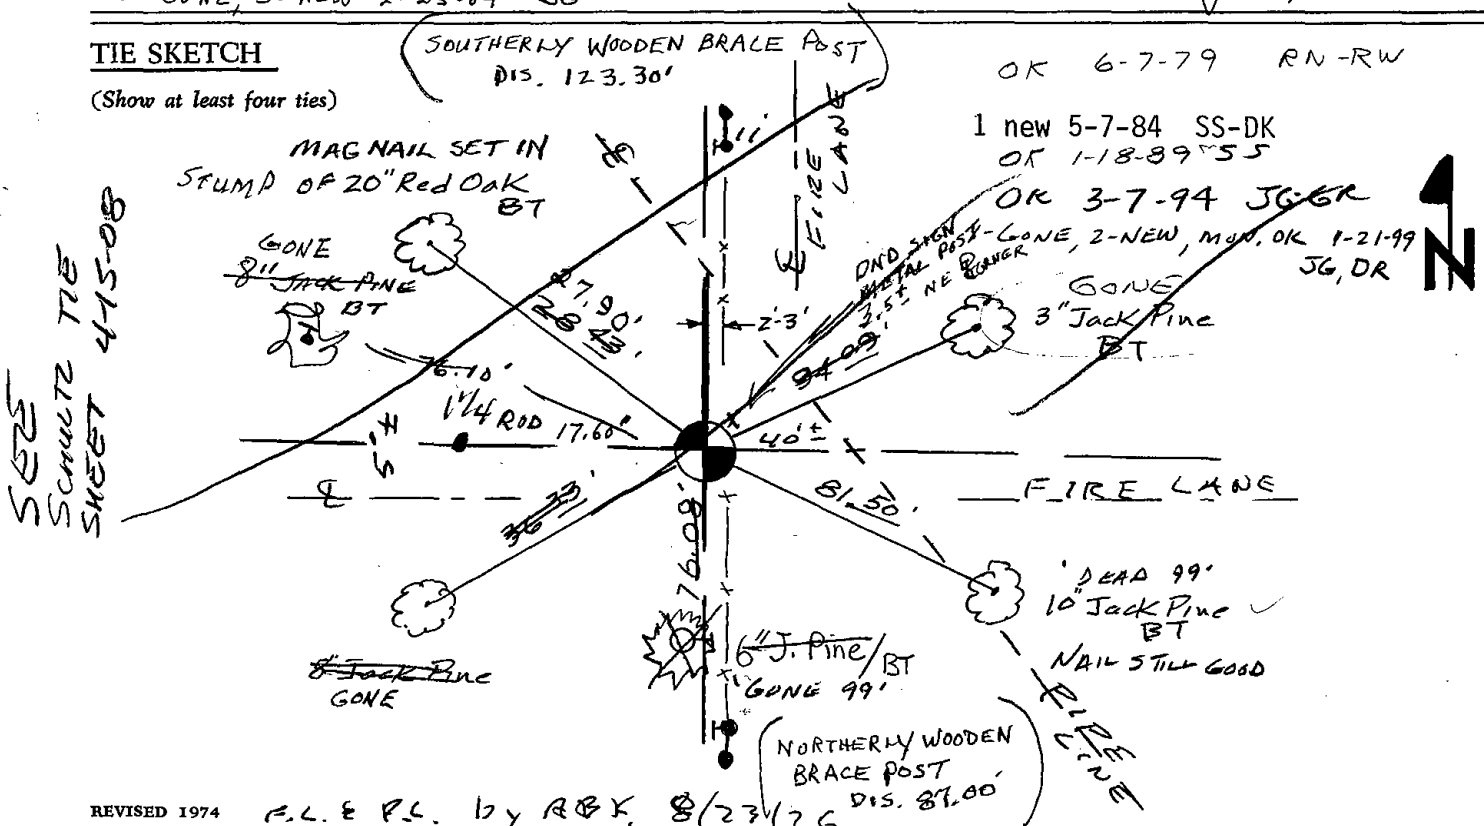
TIE SKETCH

Could not find any previous survey. There is an old fence that runs to the north. Excavation found nothing except two small pieces of sand stone. The 5/4 corner Harrison was set on a straight line between the Harrison at the S.E. corner and the old govt. post found by Kiedrowski (where he will set a Harrison) at the SW corner and prorated the distance from the original govt survey. This put the Harrison 2'to 3' west of the old fence.

3-GONE, 3-NEW 2-25-84 - JG
