## PUBLIC LAND SURVEY MONUMENT RECORD

TYPE OF MONUMENT: HARRISON (BROKEN-TOP)  
 ADAMS COUNTY COORDINATES, NAD 83 (2007)

# Government Land Corner Certificate

CORNER NO. 51  
 SECTION 14  
 TOWN 20  
 RANGE 6

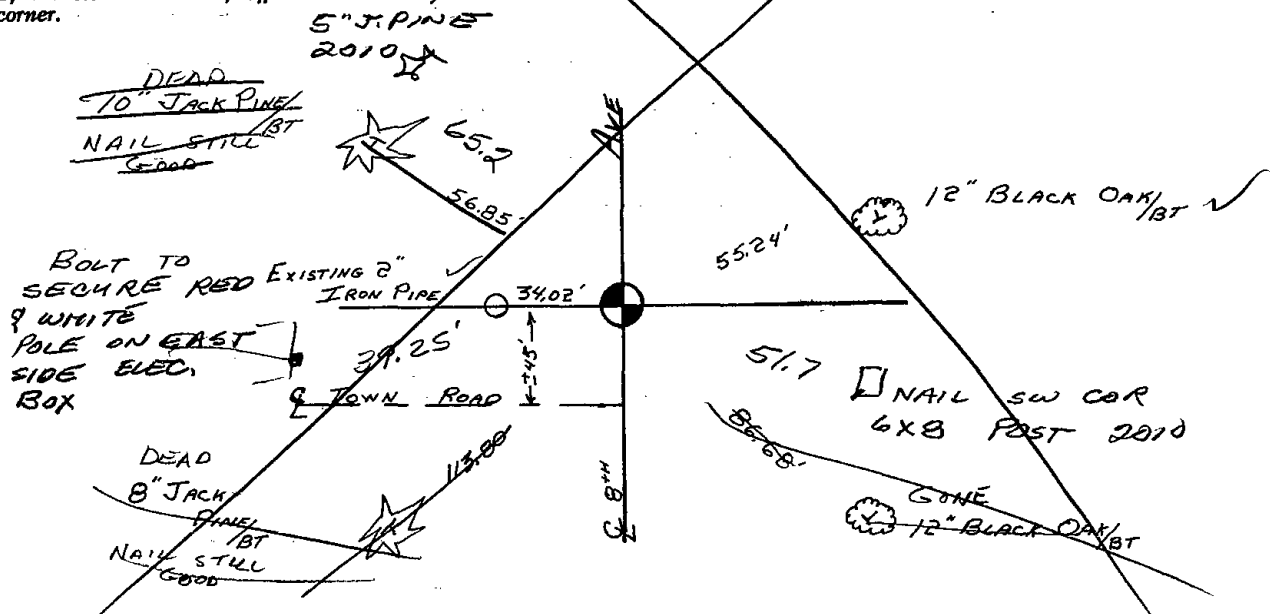
## TIE SKETCH

Accepted existing spike as corner.  
 Careful evaluation of a traverse of Section 13 and section 12 indicated this as the most correct location for the corner.
