PUBLIC LAND SURVEY MONUMENT RECORD

Survey Monument Record

CORNER NO. 699 ⁽⁶²⁾

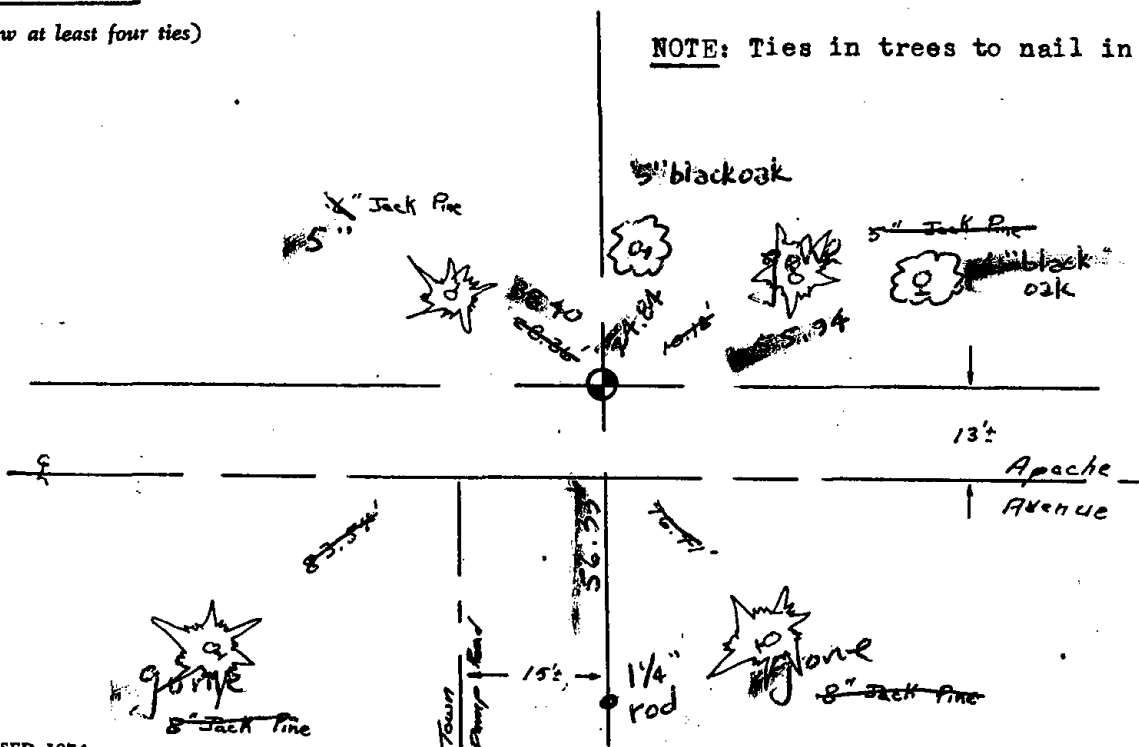
TIE SKETCH

3-19-76 NEW TIES *Steve Hylley*

NOTE: Ties in trees to nail in disc.
