## PUBLIC LAND SURVEY MONUMENT RECORD

TYPE OF MONUMENT: 1" OD IRON PIPE (NO CAP)  
 ADAMS COUNTY COORDINATES, NAD 83 (2007)

RECORD AND CERTIFICATION OF U.S. PUBLIC LAND SURVEY CONTROL STATION

Survey Monument Record

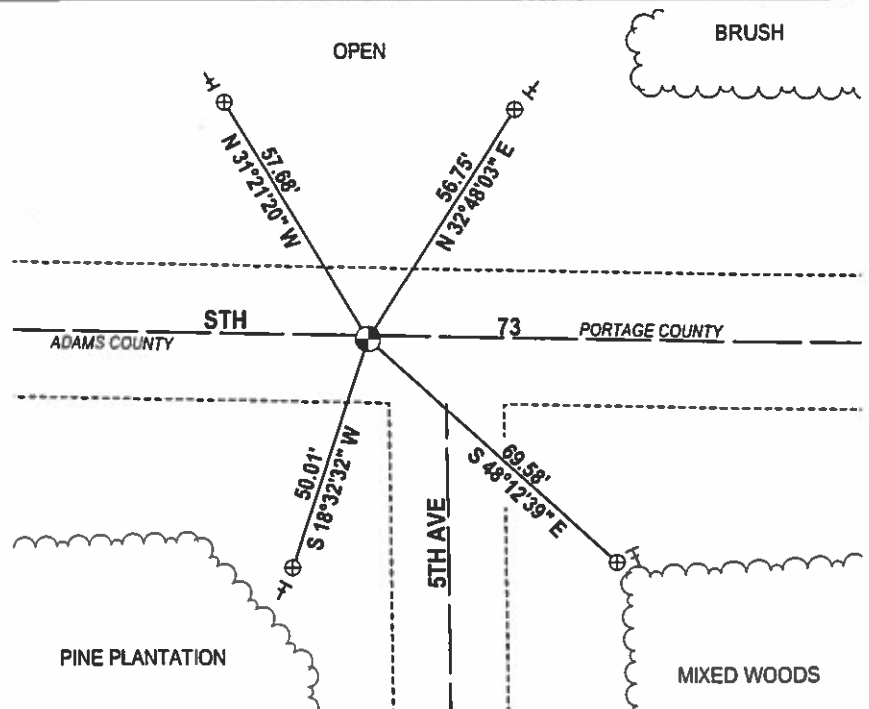
### - TIE SKETCH -

2017 - PLS 2994 FOUND A MAG NAIL IN ROAD SURFACE REMOVED DUG DOWN 4 INCHES FOUND A SURVEY NAIL SHAFT, CONTINUED DIGGING AND FOUND A 1" OD IRON PIPE 8 INCHES BELOW THE ROAD SURFACE, FOUND 4 EXISTING TIES. THE 1" IRON PIPE AGREES WITH THE TIES AND WITNESS AND ACCEPTED THE 1" OD IRON PIPE.

NOTE: THE CORNER FALLS 1½ SOUTH OF THE CENTERLINE OF STH 73. AND 16½ WEST OF 5TH AVE CENTERLINE

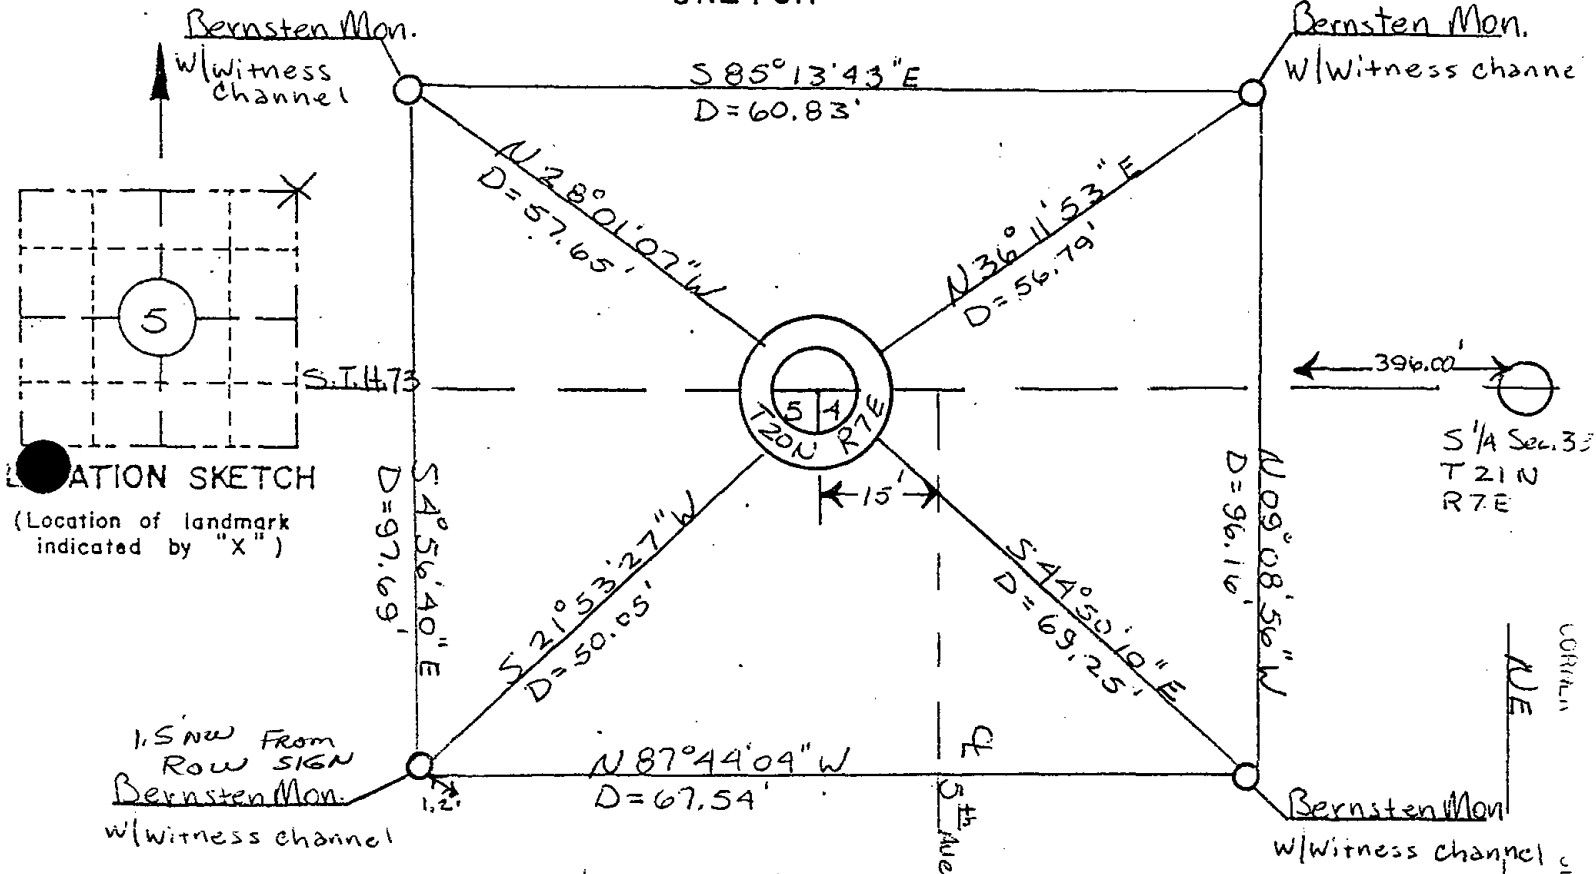
SKETCH

I hereby certify that on the 4<sup>th</sup> day of April 1991, that I did locate the above corner which was evidenced by Alum. Hwy. Cap; I further certify that to perpetuate the location of such corner I did, at the exact location thereof, place a permanent marker consisting of \_\_\_\_\_

\_\_\_\_\_ ; I further certify that I did establish 4 references or witness monuments consisting of 4 Bernsten Monuments w/witness markers located as shown above:

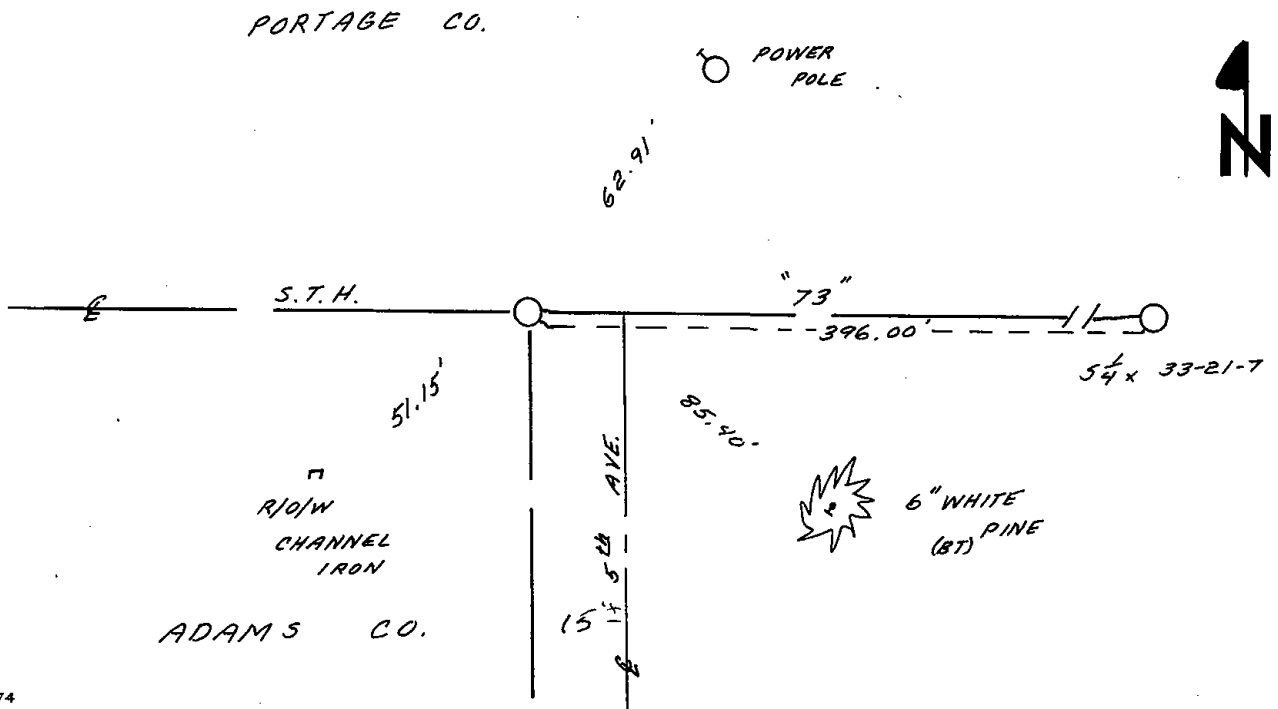
TIE SKETCH

Set on a straight line between the S $\frac{1}{4}$  and SW corners of section 33-21-7 and at the distance west from the S $\frac{1}{4}$  corner as called for in the original notes. Could find no evidence of the corner.

TIES S Mon. O.K. 3-23-79 D.W. - P.N.  
SEE ATTACHED PAGE ALSO 4-4-91
