01
SECTION

ADAMS COUNTY

COUNTY CORNER NO: 32
ROMPORTOL ID: 42007010020

PUBLIC LAND SURVEY MONUMENT RECORD

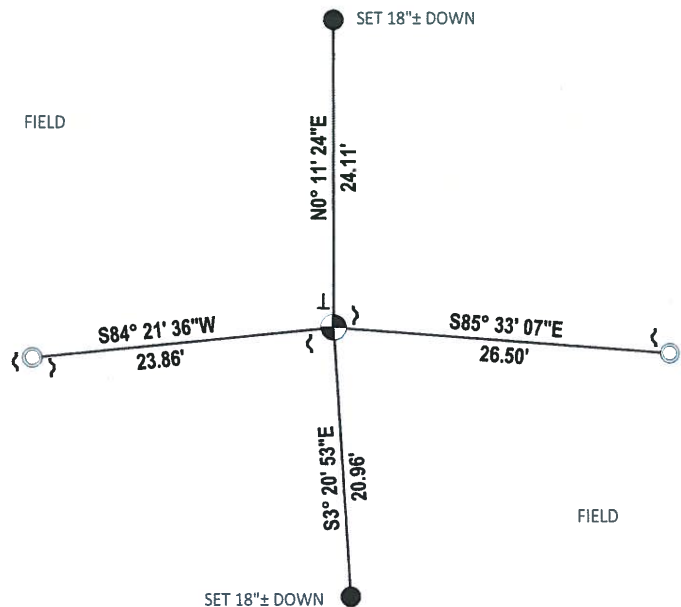
TIE SKETCH

2020 - PLS 2675 FOUND HARRISON (BROKEN-TOP) 6"± BELOW THE GROUND AND 2 TIES. THE MONUMENT AGREES WITH BOTH TIES. ACCEPTED THE HARRISON (BROKEN-TOP) AS THE CORNER LOCATION. SET 2 NEW TIES AND MEASURED TO THE EXISTING TIES.

NOTE: THE CORNER LANDS IN AREA OF NO TILLAGE CROP LAND.

- SET 3/4" x 18" IRON REBAR, 1.50#/FT
- FOUND 1-1/4" O.D. IRON PIPE
- ⊕ FOUND HARRISON (BROKEN-TOP) MONUMENT
- ~ STEEL FENCE POST

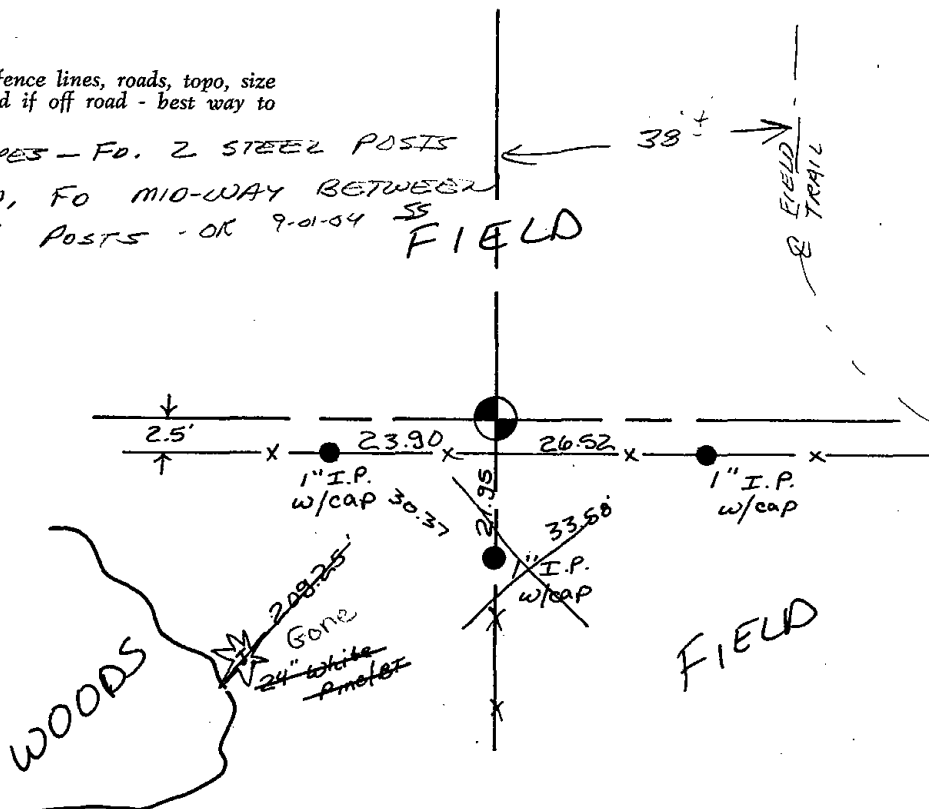
TIE SKETCH

Set corner on line between the SE corner of Section 1 and SW corner of Section 1 opposite fence line to the South. If corner placed equidistant, it would fall 20' East of fence. Held the fence as best available evidence. No resurveys of record. Could find no bearing trees or any monument.

TOP 6" OF MONUMENT BROKEN OFF, OK
2"x4" MONUMENT FOR WIFE LIT START 6-19-79 JB-CR

FO HAR & 2 PIPES - FO. 2 STEEL POSTS
ALL - MON, FO MID-WAY BETWEEN
EACH SET OF POSTS - OK 9-01-04 FIELD
