PUBLIC LAND SURVEY MONUMENT RECORD

TYPE OF MONUMENT: HARRISON (BROKEN TOP)
ADAMS COUNTY COORDINATES, NAD 83 (2007)

CORNER NO. 567
SECTION 35
TOWN 14
RANGE 6

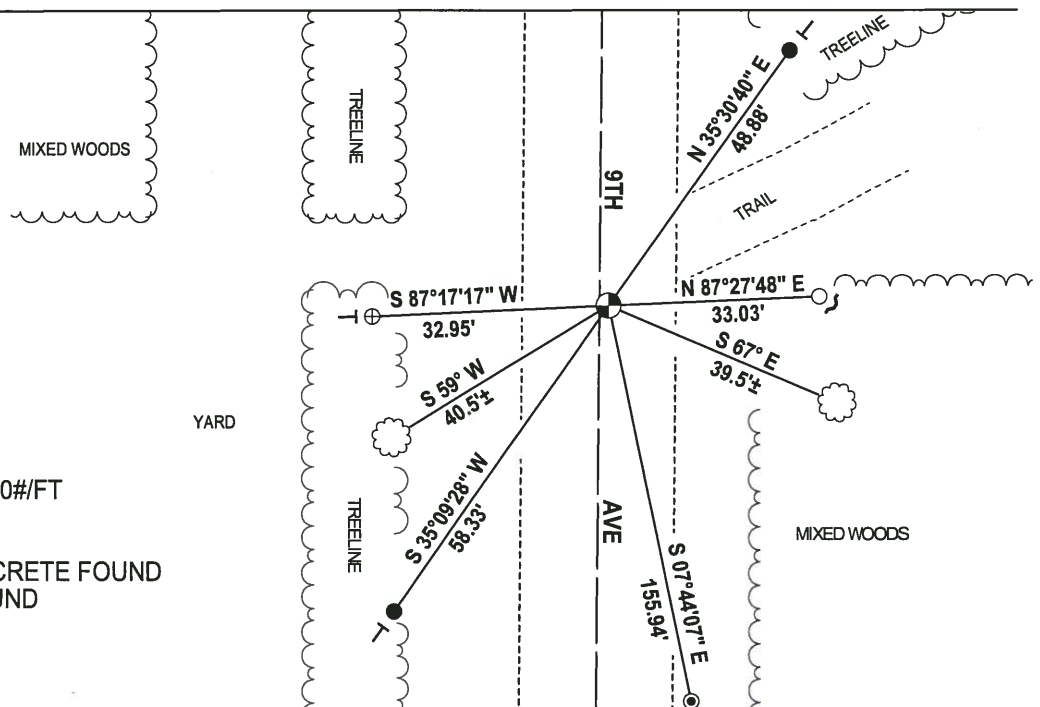
- TIE SKETCH

2017 - PLS 2994 FOUND HARRISON MONUMENT WITH A BROKEN TOP 10" UNDER THE ROAD SURFACE. 3 TIES AND 2 WITNESSES. THE MONUMENT AGREES WITH THE EXISTING TIES AND WITNESSES. ACCEPTED HARRISON WITH BROKEN TOP AS THE CORNER LOCATION. SET 2 NEW TIES AND RE-MEASURED TO THE EXISTING TIES AND WITNESSES.

NOTE: THE CORNER FALLS 2± EAST OF THE CENTERLINE OF 9TH AVE.

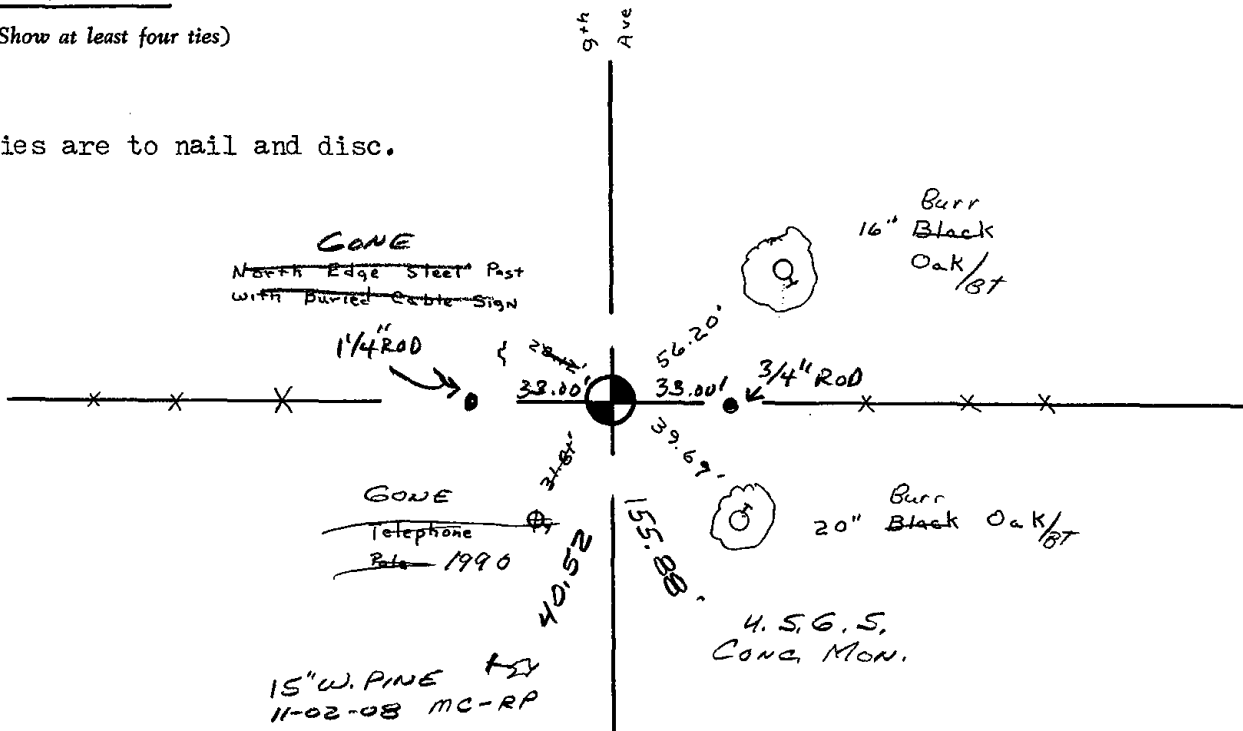
TIE SKETCH

Replaced railroad spike used as corner in the survey of the Follendorf property by Midstates. Our EDM check of this corner verified the location.

Ties are to nail and disc.

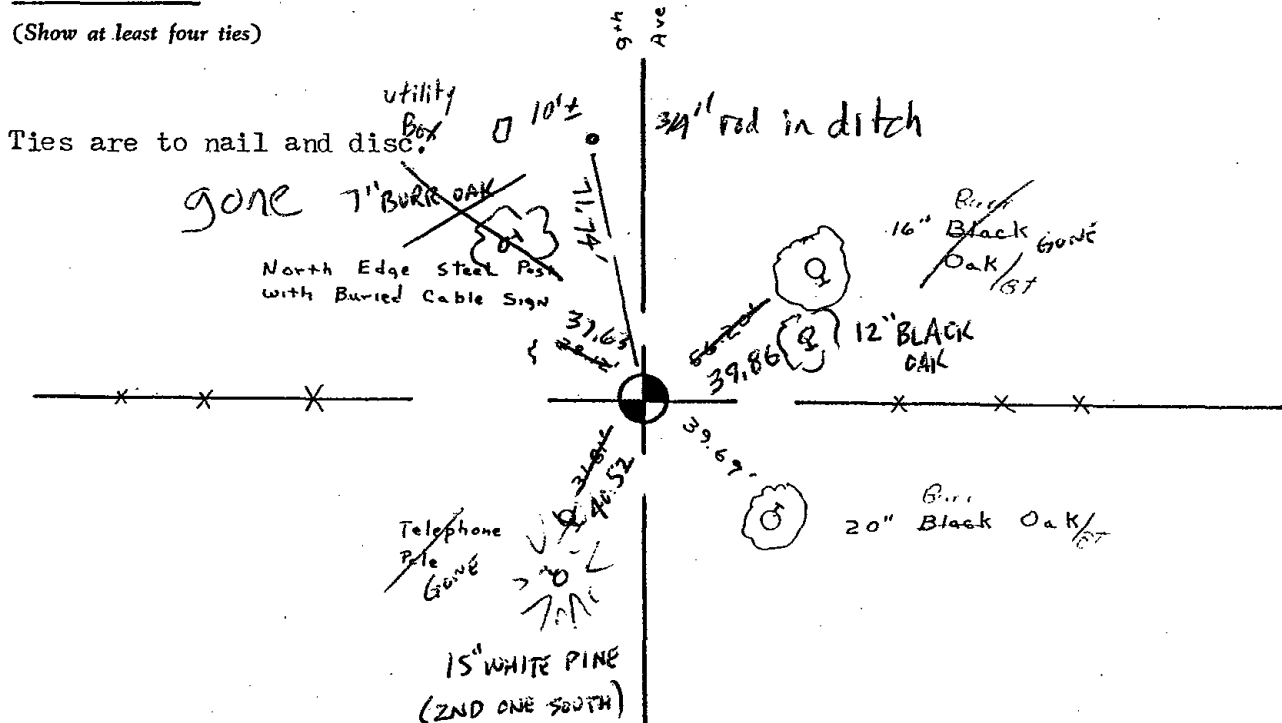
TIE SKETCH

Replaced railroad spike used as corner in the survey of the Follendorf property by Midstates. Our EDM check of this corner verified the location.

CORNER O.K. 10-9-76 GR-SS
 CORNER O.K. 12-16-81 SK-DW
 CORNER O.K. 2-6-86 CR-SS
 NEW TIES 12-14-98 SH-BF
 Top Broken off 11-2-88 MC+RP
 one new tie
