PUBLIC LAND SURVEY MONUMENT RECORD

TYPE OF MONUMENT: HARRISON (BROKEN-TOP)
ADAMS COUNTY COORDINATES, NAD 83 (2007)

CORNER NO. 98
SECTION 26
TOWN 14N
RANGE 7E

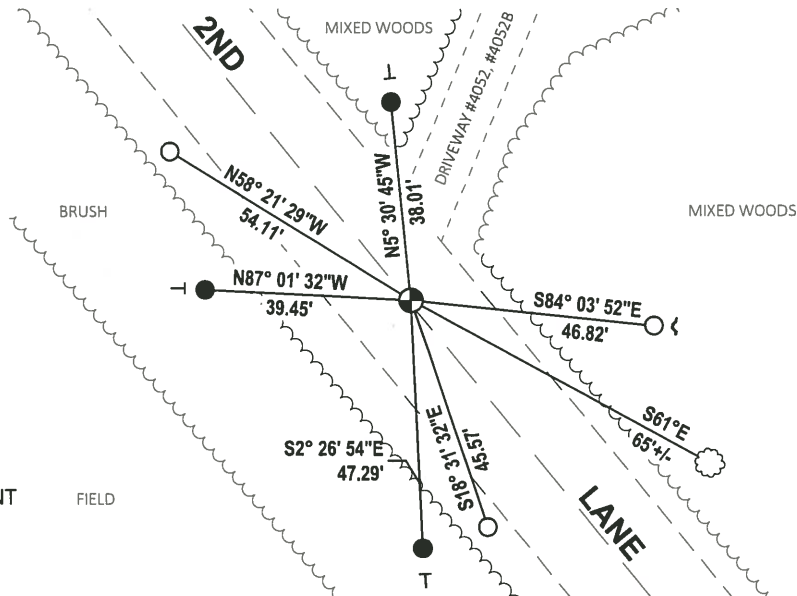
- TIE SKETCH

2020 - PLS 2675 FOUND HARRISON (BROKEN-TOP) 3"± BELOW THE ROAD SURFACE, 3 TIES AND 1 WITNESS. THE MONUMENT AGREES WITH ALL 3 TIES AND WITNESS. ACCEPTED THE HARRISON (BROKEN-TOP) AS THE CORNER LOCATION. SET 3 NEW TIES AND MEASURED TO THE EXISTING TIES AND WITNESS.

NOTE: THE CORNER LANDS ON THE CENTERLINE OF 2ND LANE.

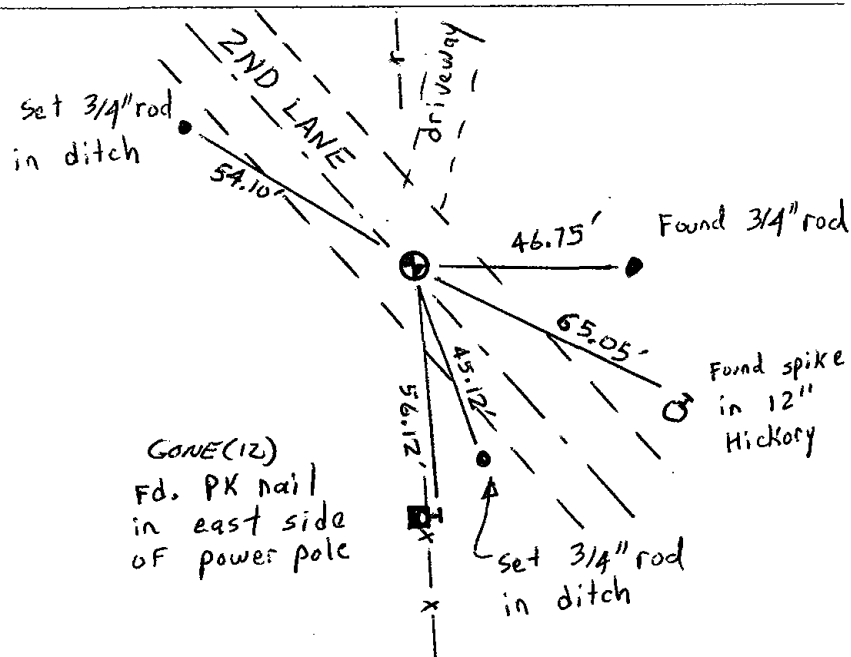
TIE SKETCH

I found monument and two ties from AL Rohde 10-7-76 tie sheet. AL Rohde had found 3" x 8" x 8" sandstone with cross and buggy axle at centerline. He replaced stone with harrison monument.

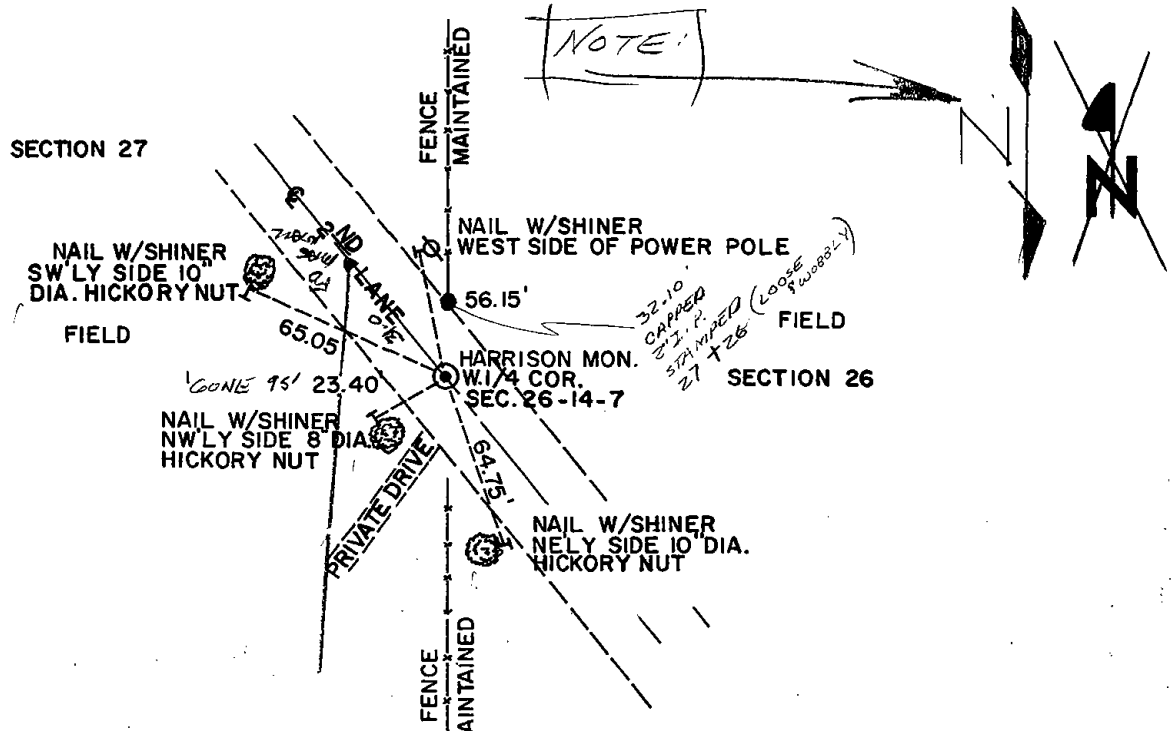
TIE SKETCH

Researched Adams County survey notes and original gov't notes found nothing as being set at corner on record. Looked for original gov't bearing trees but have been destroyed. Sounded & Road in line with m-s fence line and picked up metal object. Dug and found 3" x 8" x 8" sandstone 12" below surface of Road with cross on top with buggy axle underneath. Set HARRISON at this point. Ed.M. TRAVERSE
