# ADAMS COUNTY

COUNTY CORNER NO: 93

## PUBLIC LAND SURVEY MONUMENT RECORD

Survey Monument Record

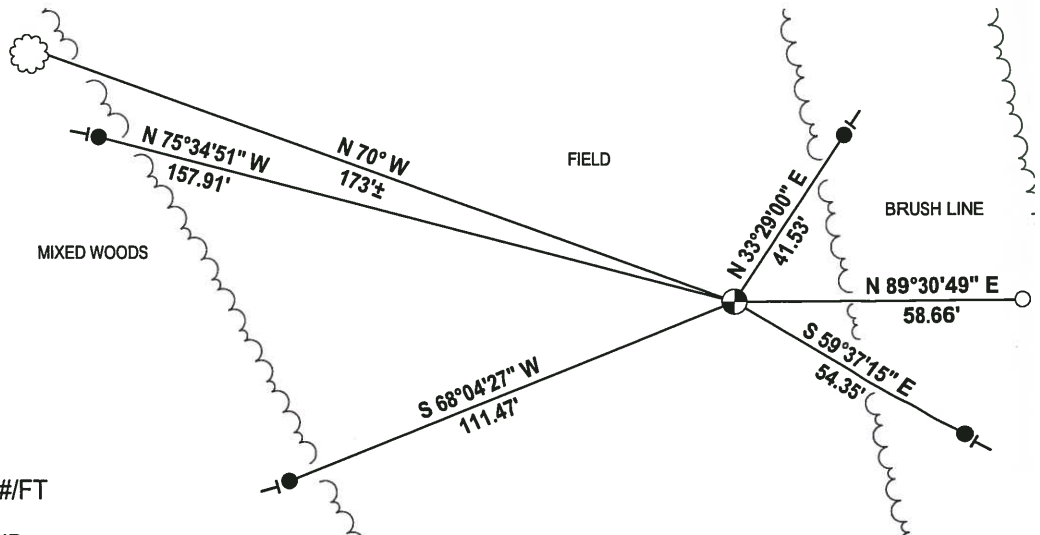
### - TIE SKETCH

NOTE: THE CORNER FALLS 125± WEST OF THE CENTERLINE OF STH 113.

- 3/4" x 18" IRON REBAR SET, 1.50#/FT
- 3/4" IRON ROD FOUND
- ⊕ HARRISON (BROKEN-TOP) FOUND
- VINYL "T" POST
- ☁ WITNESS TREE FOUND

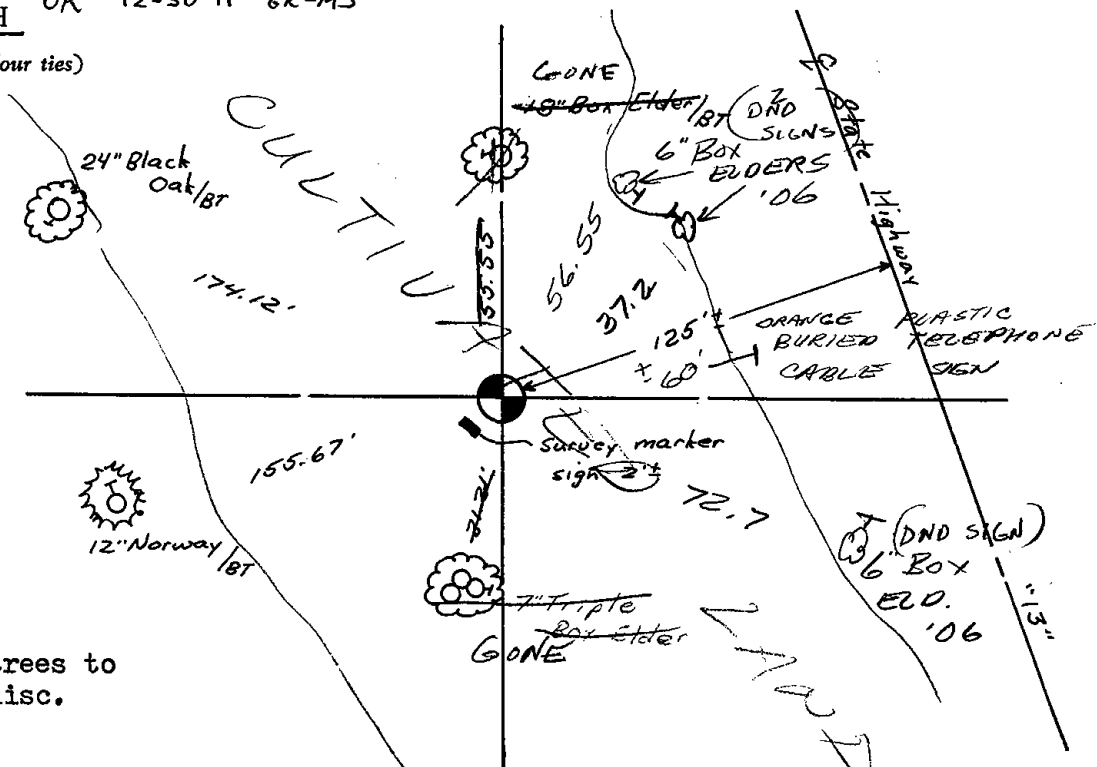
(Show at least four ties)

FO 15" DEEP - TOP BROKEN - TIES W. REMAIN
ADDED TIES AS SHOWN 6-7-06
3-NEW TIES, 6-7-06 JG-SS

NOTE:
Ties in trees to
nail in disc.

Ran EDM/transit traverse around Sections 19 and 30, to determine search areas for investigation.

Could find no evidence of the original corner or any remonumentation.

Set corner by single proportionate measure along the Town line between the adjacent Section corners.
