## PUBLIC LAND SURVEY MONUMENT RECORD

TYPE OF MONUMENT: HARRISON (BROKEN-TOP)  
 ADAMS COUNTY COORDINATES, NAD 83 (2007)

CORNER NO. 85  
SECTION 23  
TOWN 15  
RANGE 6

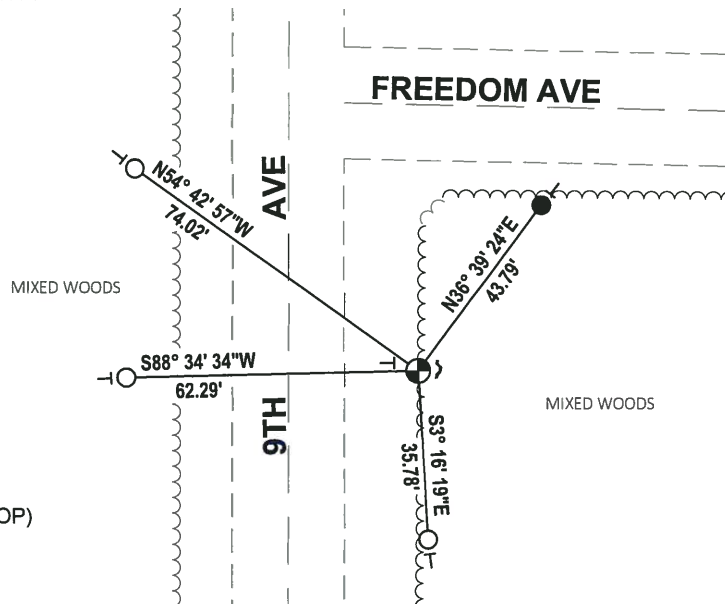
### TIE SKETCH

NOTE: THE CORNER FALLS 28± EAST OF THE CENTERLINE OF 9TH AVE AND 56± SOUTH OF THE CENTERLINE OF FREEDOM AVE.

- SET 3/4" x 18" IRON REBAR, 1.50#/FT
- FOUND 3/4" IRON ROD
- ⊕ FOUND HARRISON MONUMENT (BROKEN-TOP)
- ↗ STEEL FENCE POST
- ⊥ VINYL "T" POST

2018 - PLS 2994 FOUND A HARRISON MONUMENT WITH A BROKEN-TOP 12" BELOW THE GROUND SURFACE AND 3 TIES. THE MONUMENT AGREES WITH THE EXISTING TIES. ACCEPTED THE HARRISON MONUMENT WITH A BROKEN-TOP AS THE CORNER LOCATION. SET 1 NEW TIE AND MEASURED TO THE TIES.

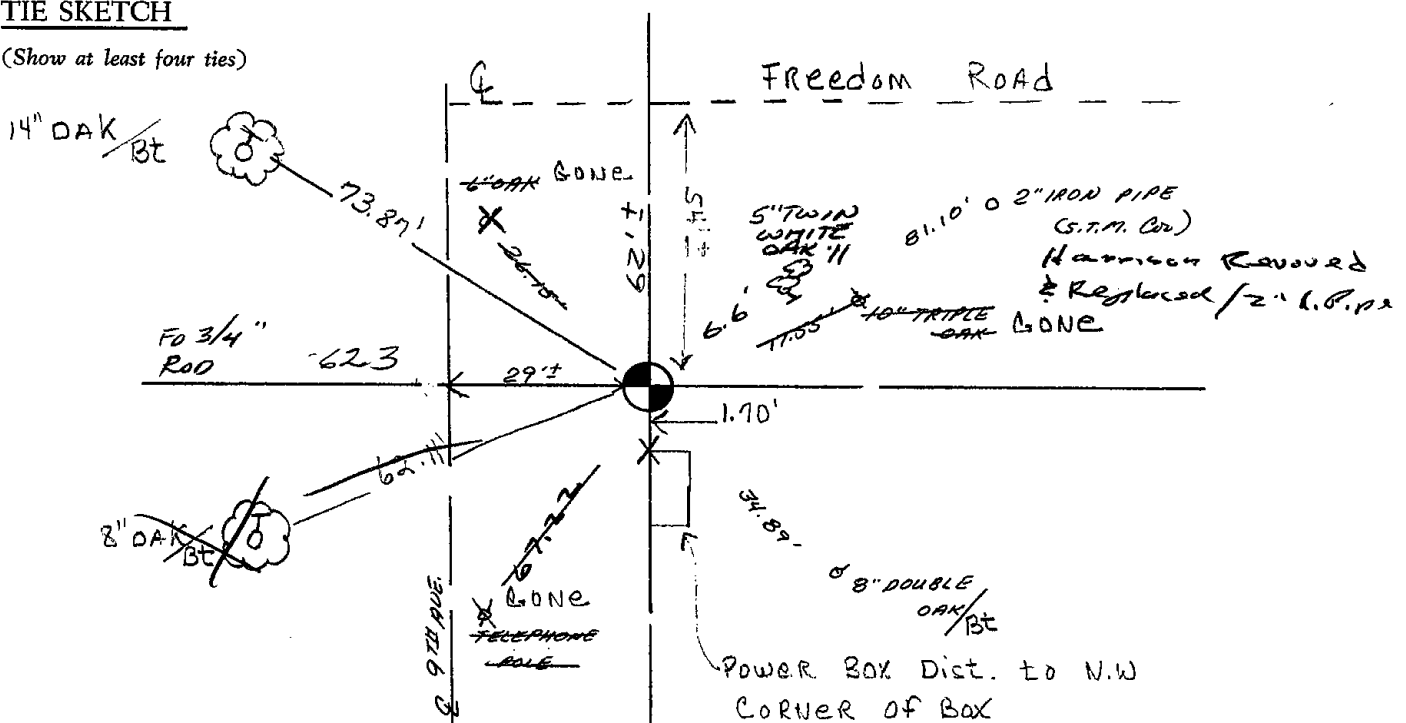
TIE SKETCH

This corner monumented by Co. Surveyor Mullen in 1971 but was disputed. The road intersection was entirely excavated with a backhoe but nothing was found. This area was in a road cut, so if anything was there, it was probably destroyed. However, analyzing an extensive traverse of all four sections around this corner, and using a record dimension by Barrett in Vol. 2, page 195 of old field notes, put this corner somewhat southeast of the road intersection. Harrison set by Mullen removed and replaced by a 2" pipe.
