32  
SECTION

# ADAMS COUNTY

COUNTY CORNER NO: 116

## PUBLIC LAND SURVEY MONUMENT RECORD

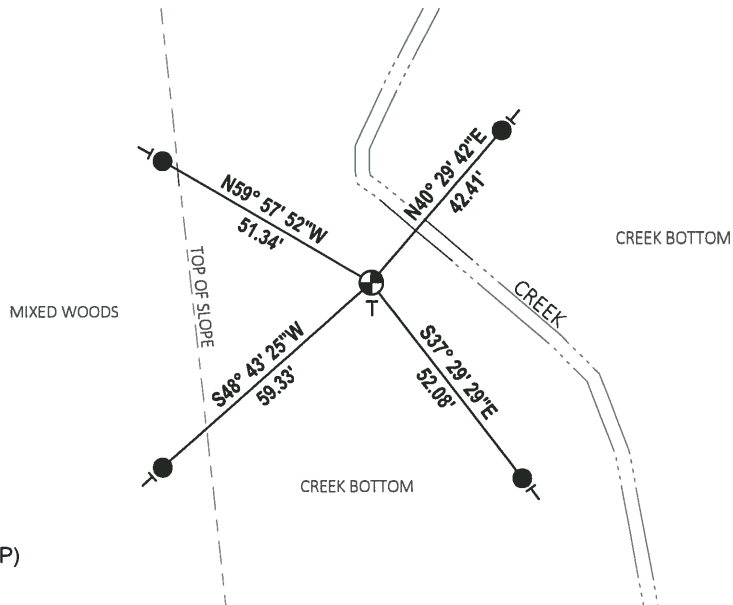
### - TIE SKETCH

2018 - PLS 2994 FOUND A HARRISON MONUMENT WITH A BROKEN-TOP FLUSH WITH THE GROUND SURFACE. FOUND NO EVIDENCE OF ANY OF THE TIES OR WITNESSES. ACCEPTED THE HARRISON MONUMENT WITH A BROKEN-TOP AS THE BEST EVIDENCE OF THE CORNER LOCATION. SET 4 NEW TIES AND MEASURED TO THE TIES.

NOTE: THE CORNER FALLS 38± EAST OF THE TOP OF SLOPE.

- SET 3/4" x 18" IRON REBAR, 1.50#/FT
- ⊕ FOUND HARRISON MONUMENT (BROKEN-TOP)
- ⊥ VINYL "T" POST

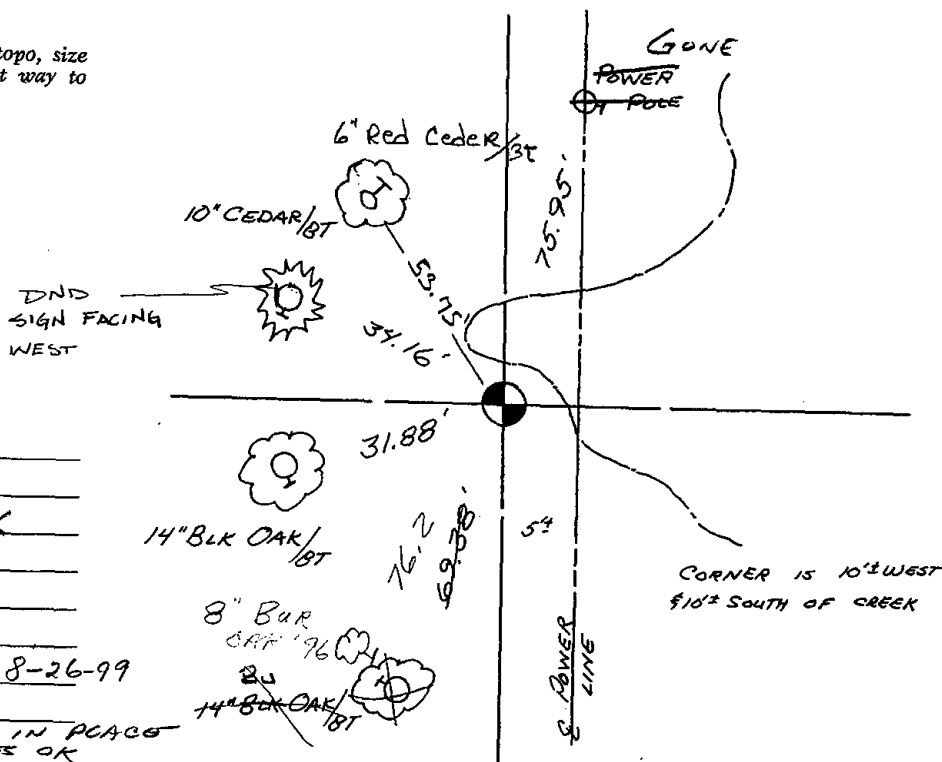
**TIE SKETCH**

Set corner equidistant and on line between adjacent Section corners. No previous monumentation was found.

Date	Init.	Remarks
12-28-81	RW-SK	MON + TIES O.K
2-3-86	GL-SS	OK
2-12-91	SS-JG	ALL OK
1-17-96	JG-SS	1 GONE / NEW
SEE ATTACHED SHEET, BRENNEMAN, 8-26-99		
2-15-01	MA-JG	ALL OK
5-26-06	SJS	TOP BROKEN - BOTTOM IN PLACE
REVISED 1977 4-15-11	OK	TIES OK
