# Government Land Corner Certificate

CORNER NO. 26  
 SECTION 9  
 TOWN 16  
 RANGE 6

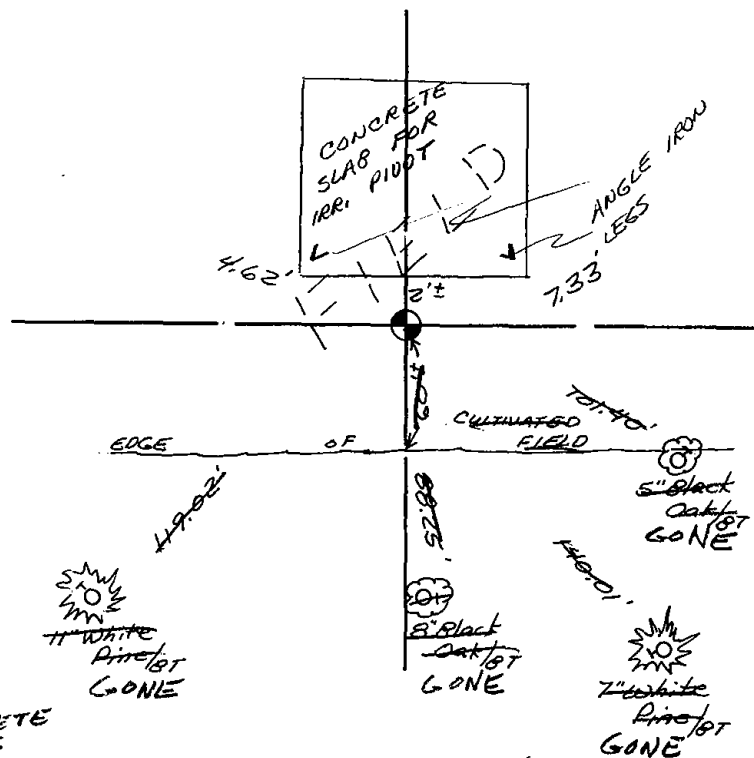
## TIE SKETCH

Set corner equidistant and on line between adjacent section corners. No evidence of any previous monumentation could be found, as the area surrounding the corner had been recently cleared and dozed for farming.

Show at least four ties, also fence lines, roads, topo, size and type of witness trees' and if off road - best way to arrive at corner.

| Date | Init. | Remarks |
|---|---|---|
| 10-31-85 | MB-SS | TIES O.K. SET 3/4" ROD |
| 2-28-05 | JG | COMPLETE AREA AROUND THE PIVOT IS IRRIGATION FIELD ONLY TIES ARE ON CONCRETE SLAB - SAME 1-20-10 SS |
