PUBLIC LAND SURVEY MONUMENT RECORD

ADAMS COUNTY

CORNER NO. 345
SECTION 7
TOWN 16
RANGE 7

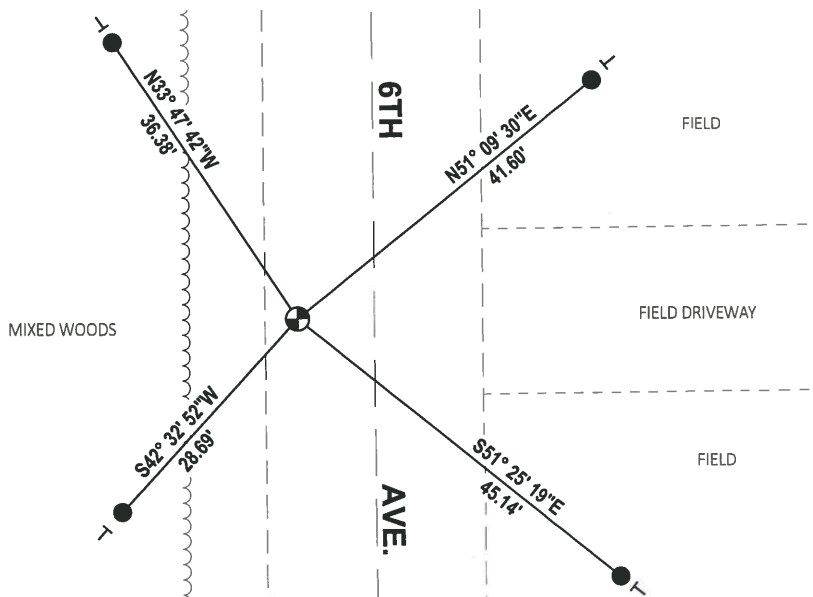
TIE SKETCH

2020 - PLS 2675 FOUND HARRISON (BROKEN-TOP) 18"± BELOW THE ROAD SURFACE AND DID NOT RECOVER ANY EXISTING TIES OR WITNESSES. ACCEPTED THE HARRISON (BROKEN-TOP) AS THE BEST AVAILABLE EVIDENCE OF THE CORNER LOCATION AND SET 4 NEW TIES.

NOTE: THE CORNER LANDS 8.4'± WEST OF 6TH AVE. CENTERLINE.

- SET 3/4" x 18" IRON REBAR, 1.50#/FT
- ⊕ FOUND HARRISON (BROKEN-TOP) MONUMENT
- ┊ VINYL "T" POST

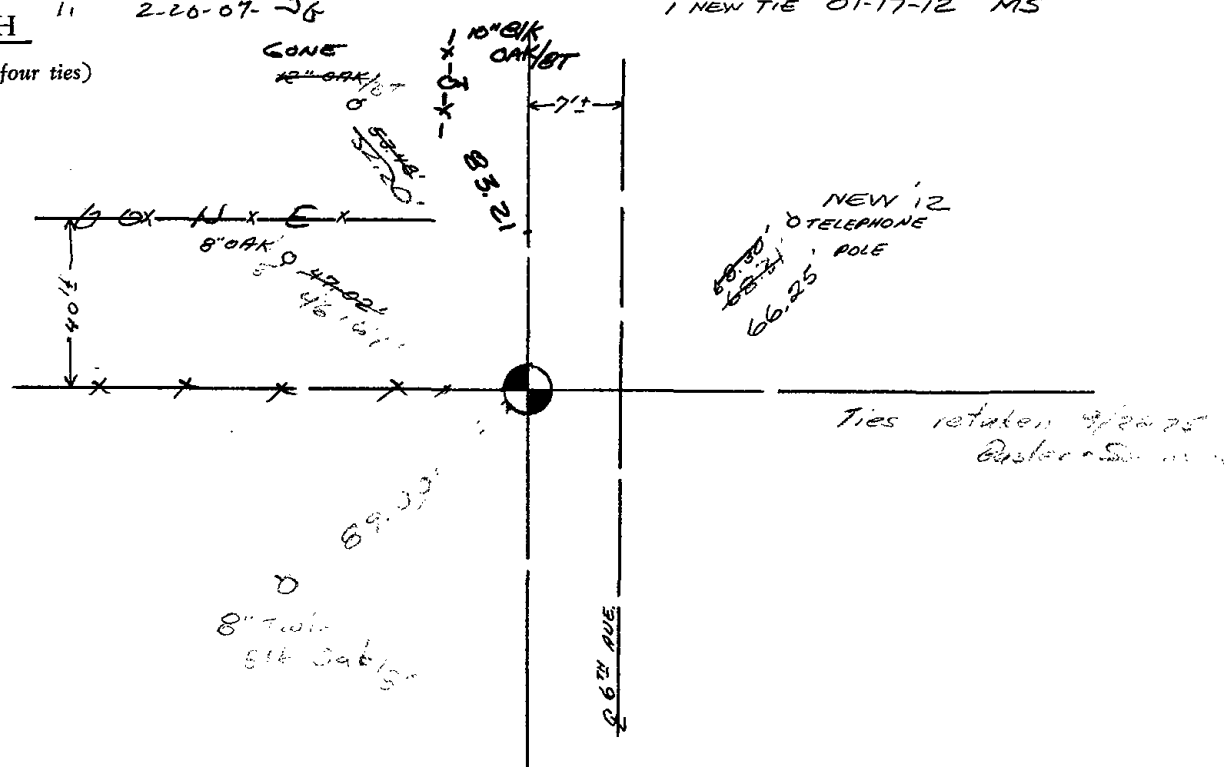
TIE SKETCH

Location determined after analyzing a taped traverse of Sec. 7. No evidence of corner found. Did not dig.
