PUBLIC LAND SURVEY MONUMENT RECORD

HARRISON (BROKEN-TOP)

Government Land Corner Certificate

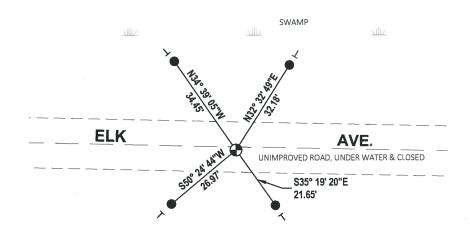
-TIE SKETCH

2020 - PLS 2675 FOUND 3/4" REBAR BENT IN THE ROAD SURFACE, REMOVED AND FOUND HARRISON (BROKEN-TOP) 24"± BELOW THE ROAD SURFACE. DID NOT RECOVER ANY EXISTING TIES OR WITNESSES. ACCEPTED THE HARRISON (BROKEN-TOP) AS THE BEST AVAILABLE EVIDENCE OF THE CORNER LOCATION AND SET 4 NEW TIES.

NOTE: THE CORNER LANDS 1'± SOUTH OF ELK AVE. CENTERLINE.

- SET 3/4" x 48" IRON REBAR, 1.50#/FT
- FOUND HARRISON (BROKEN-TOP) MONUMENT
- VINYL "T" POST

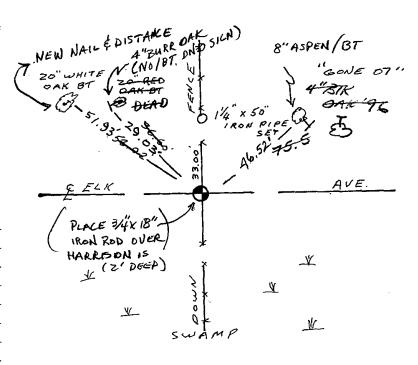
TIE SKETCH

Excavated with backhoe. Found $6 \times 10 \times 12$ " black granite stone set upright. Lowered stone and set Harrison Monument on top.
